The 2 earthquakes of February 6th 2023 in Turkey

PRELIMINARY REPORT

Failures of Multistorey Buildings

PART B: Structural Collapse and Interpretation

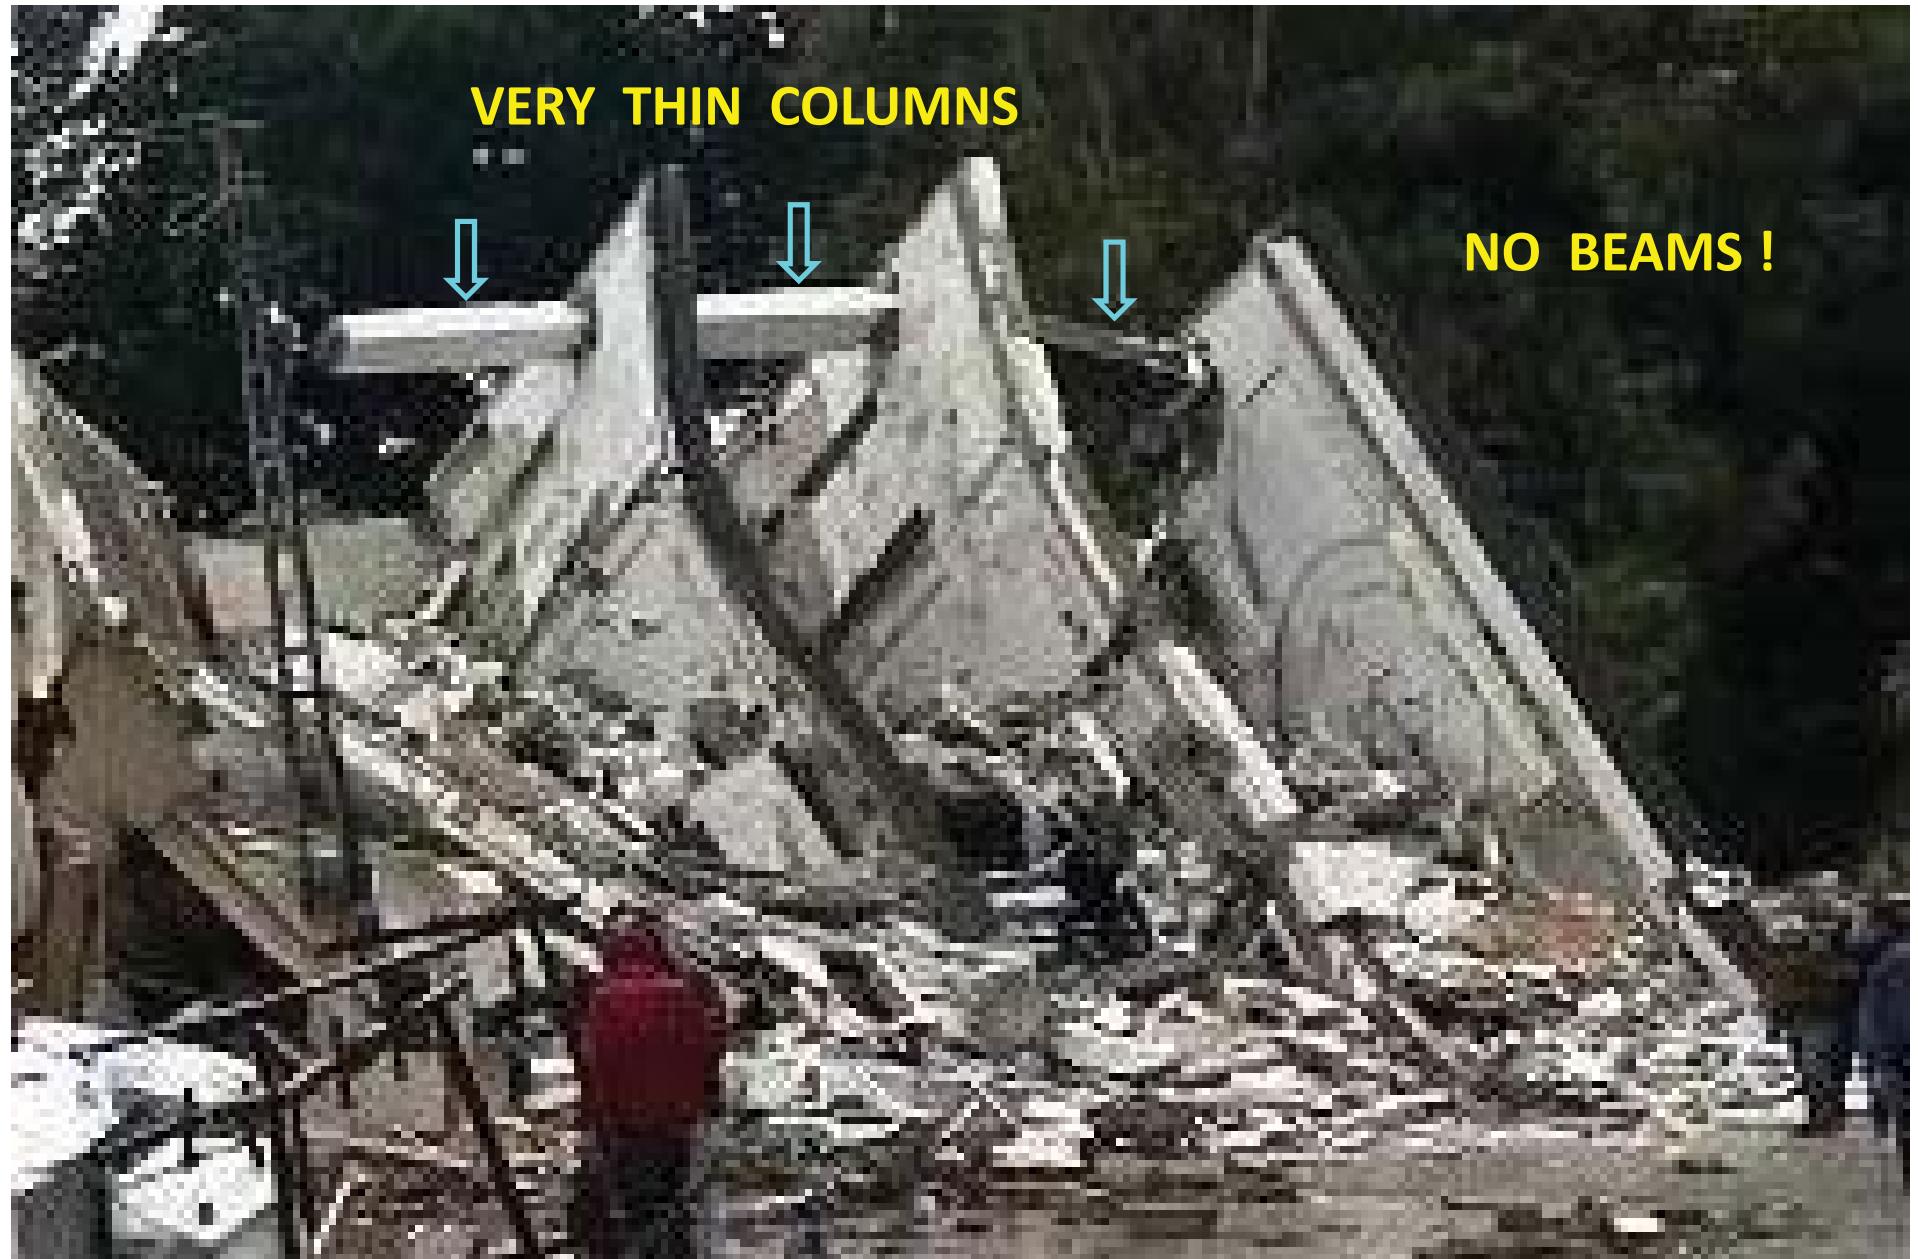
Numerous buildings without any beam, with small size columns
(inappropriate even for 1-story buildings in a region of moderate seismicity).²⁴

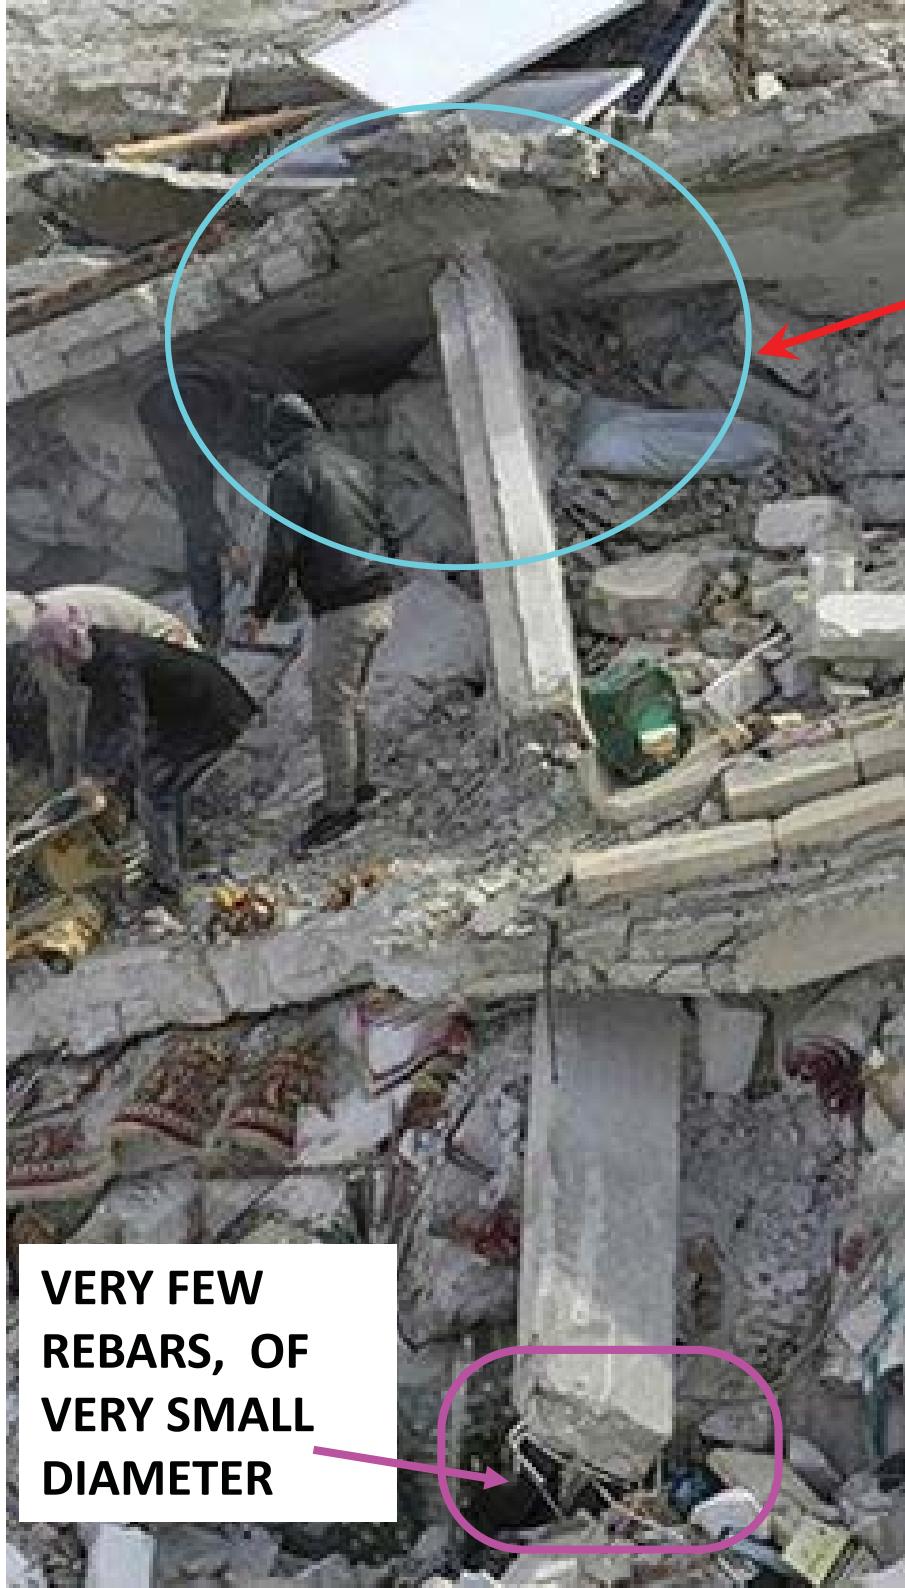
NO BEAMS
NO SHEAR WALLS

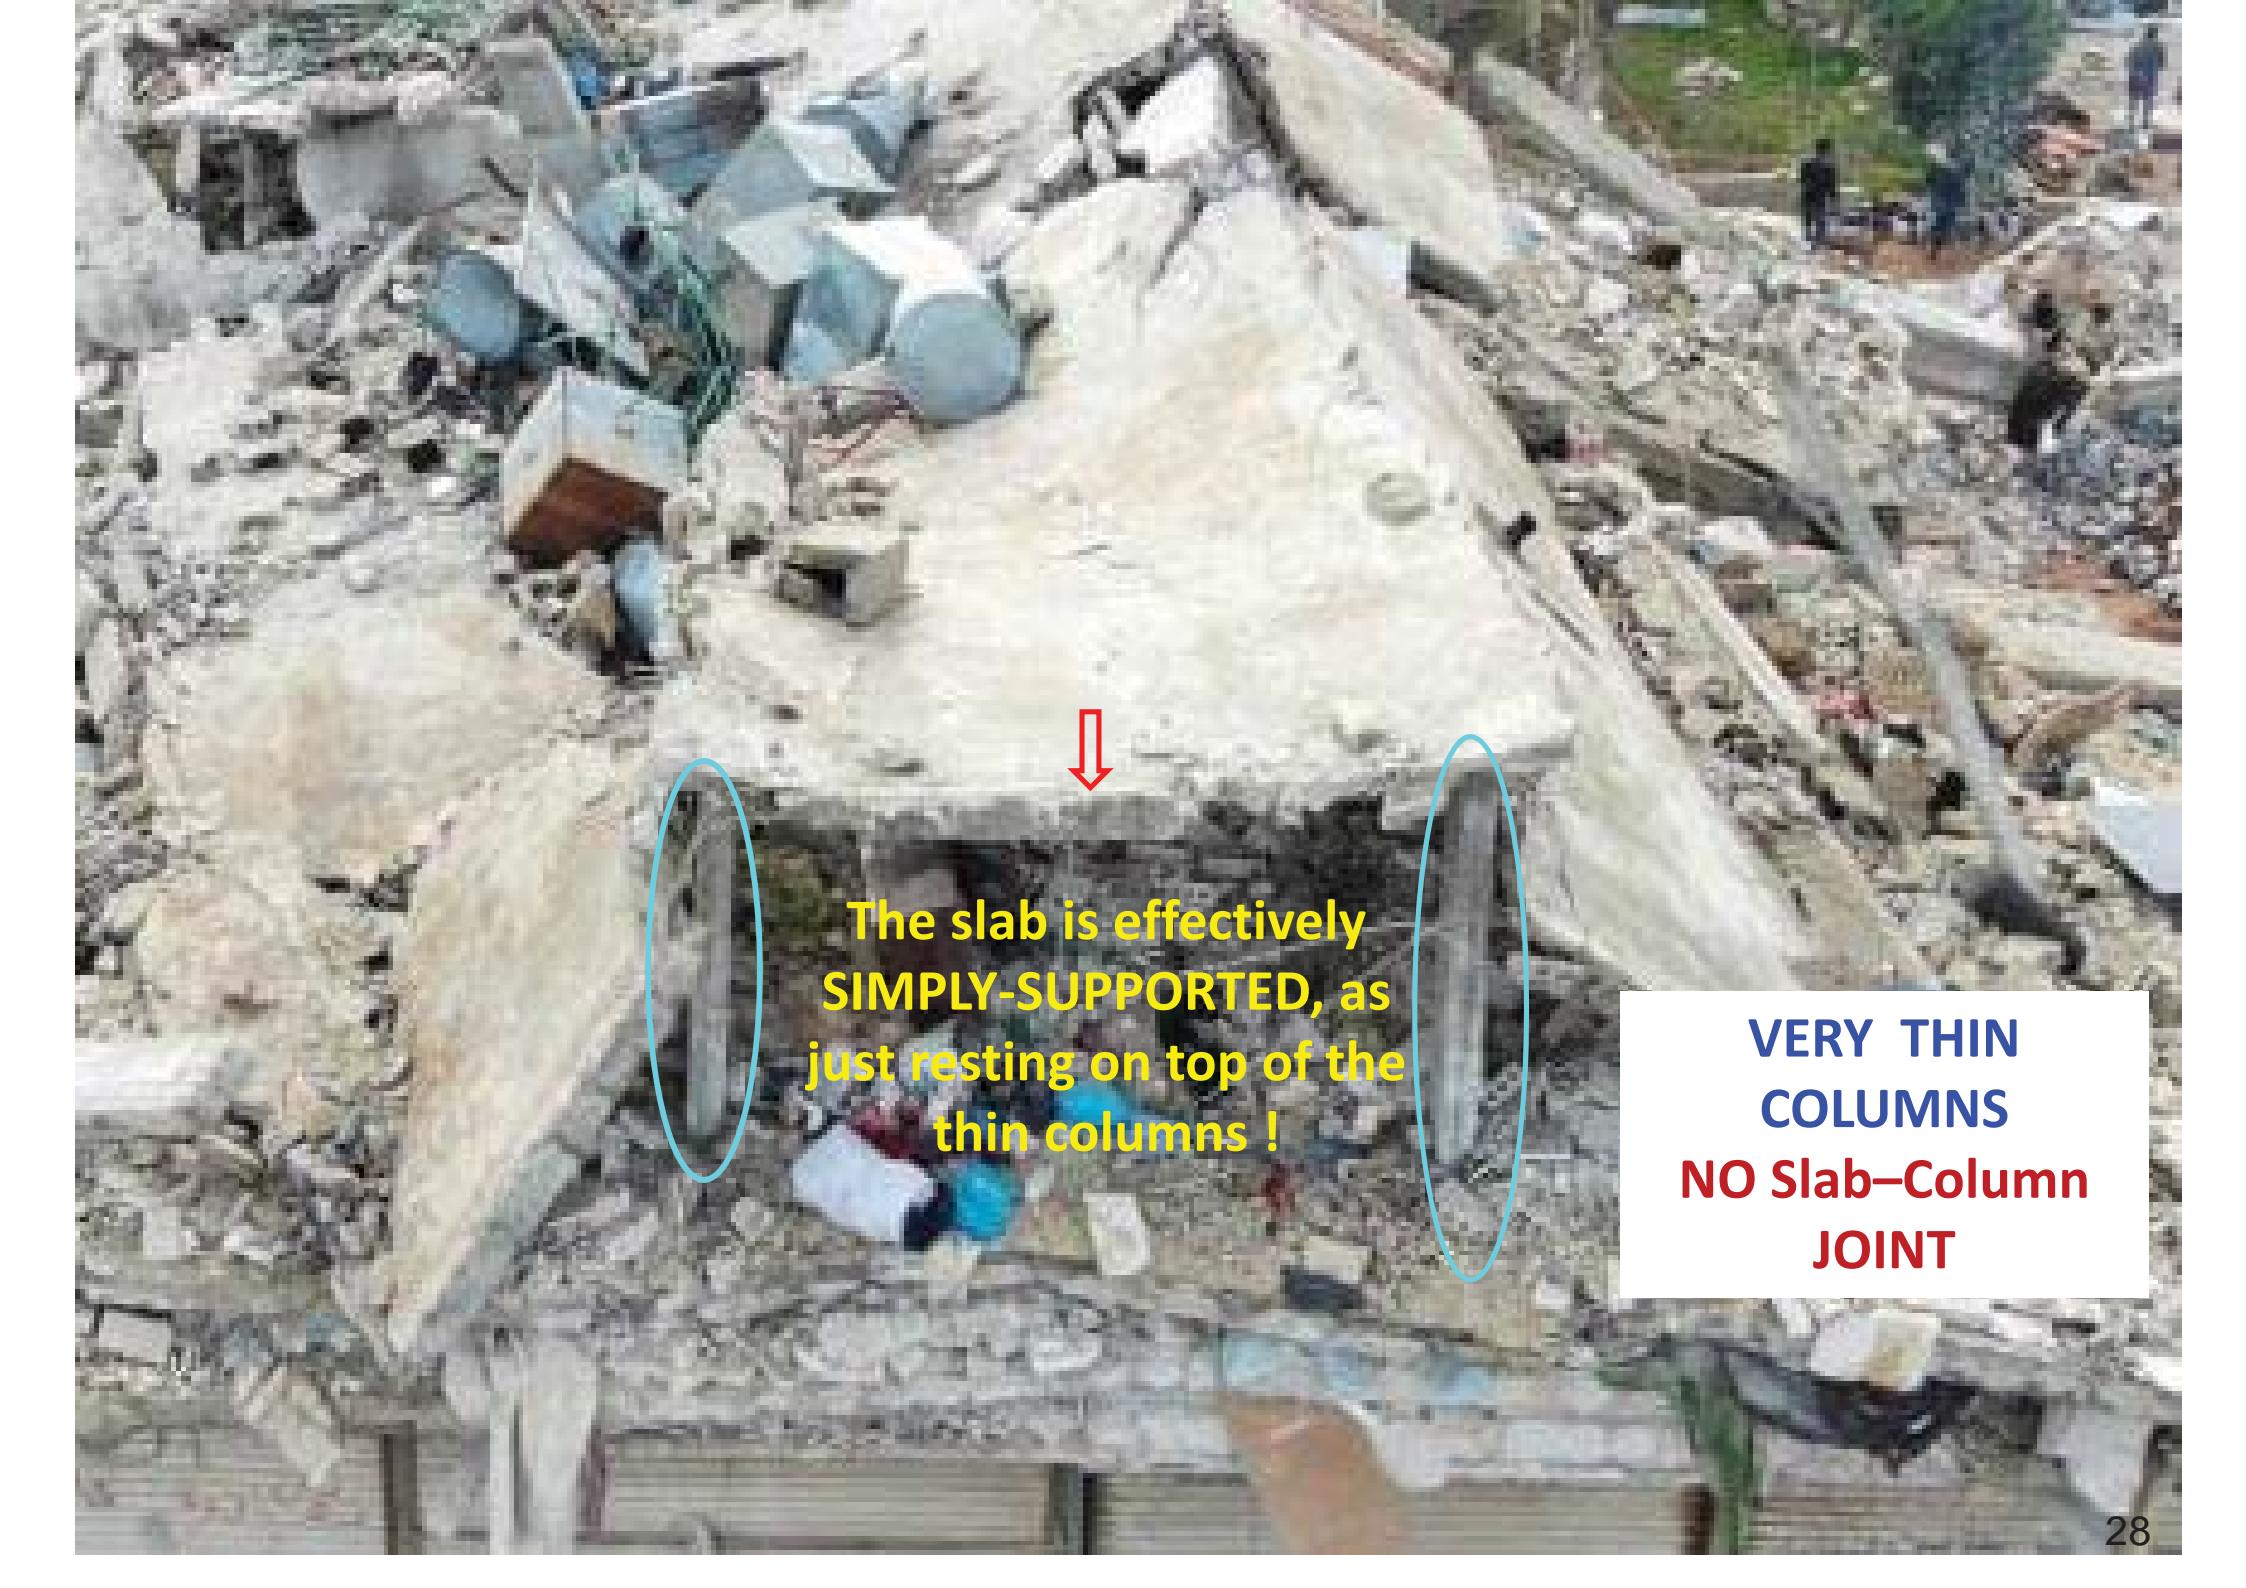
The slab is effectively
SIMPLY-SUPPORTED, as
just resting on top of the
thin columns !

**VERY THIN
COLUMNS**
**NO Slab-Column
JOINT**

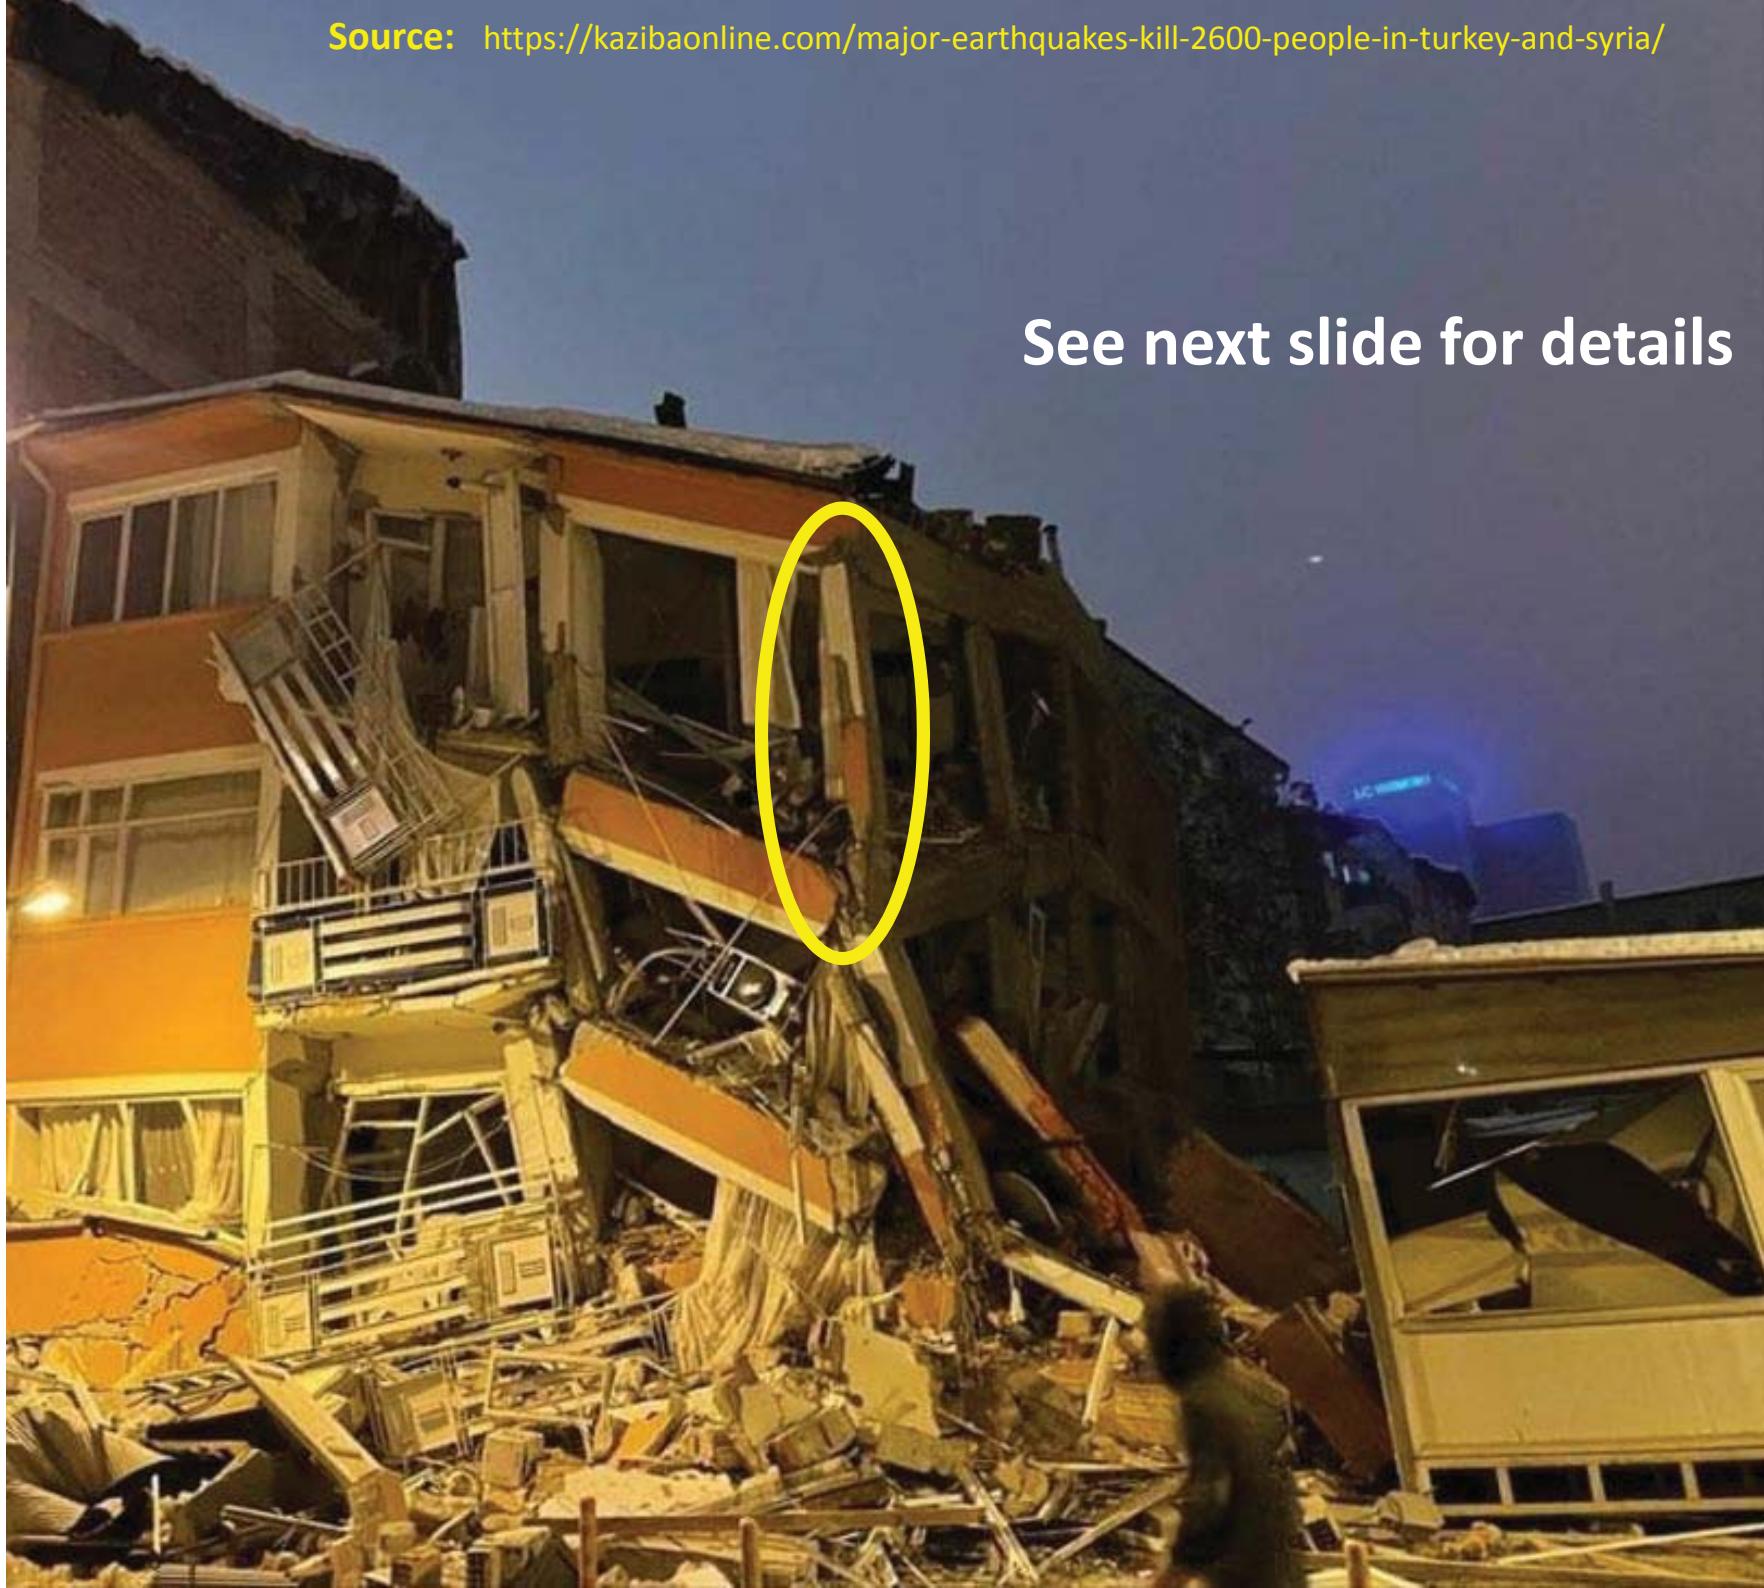
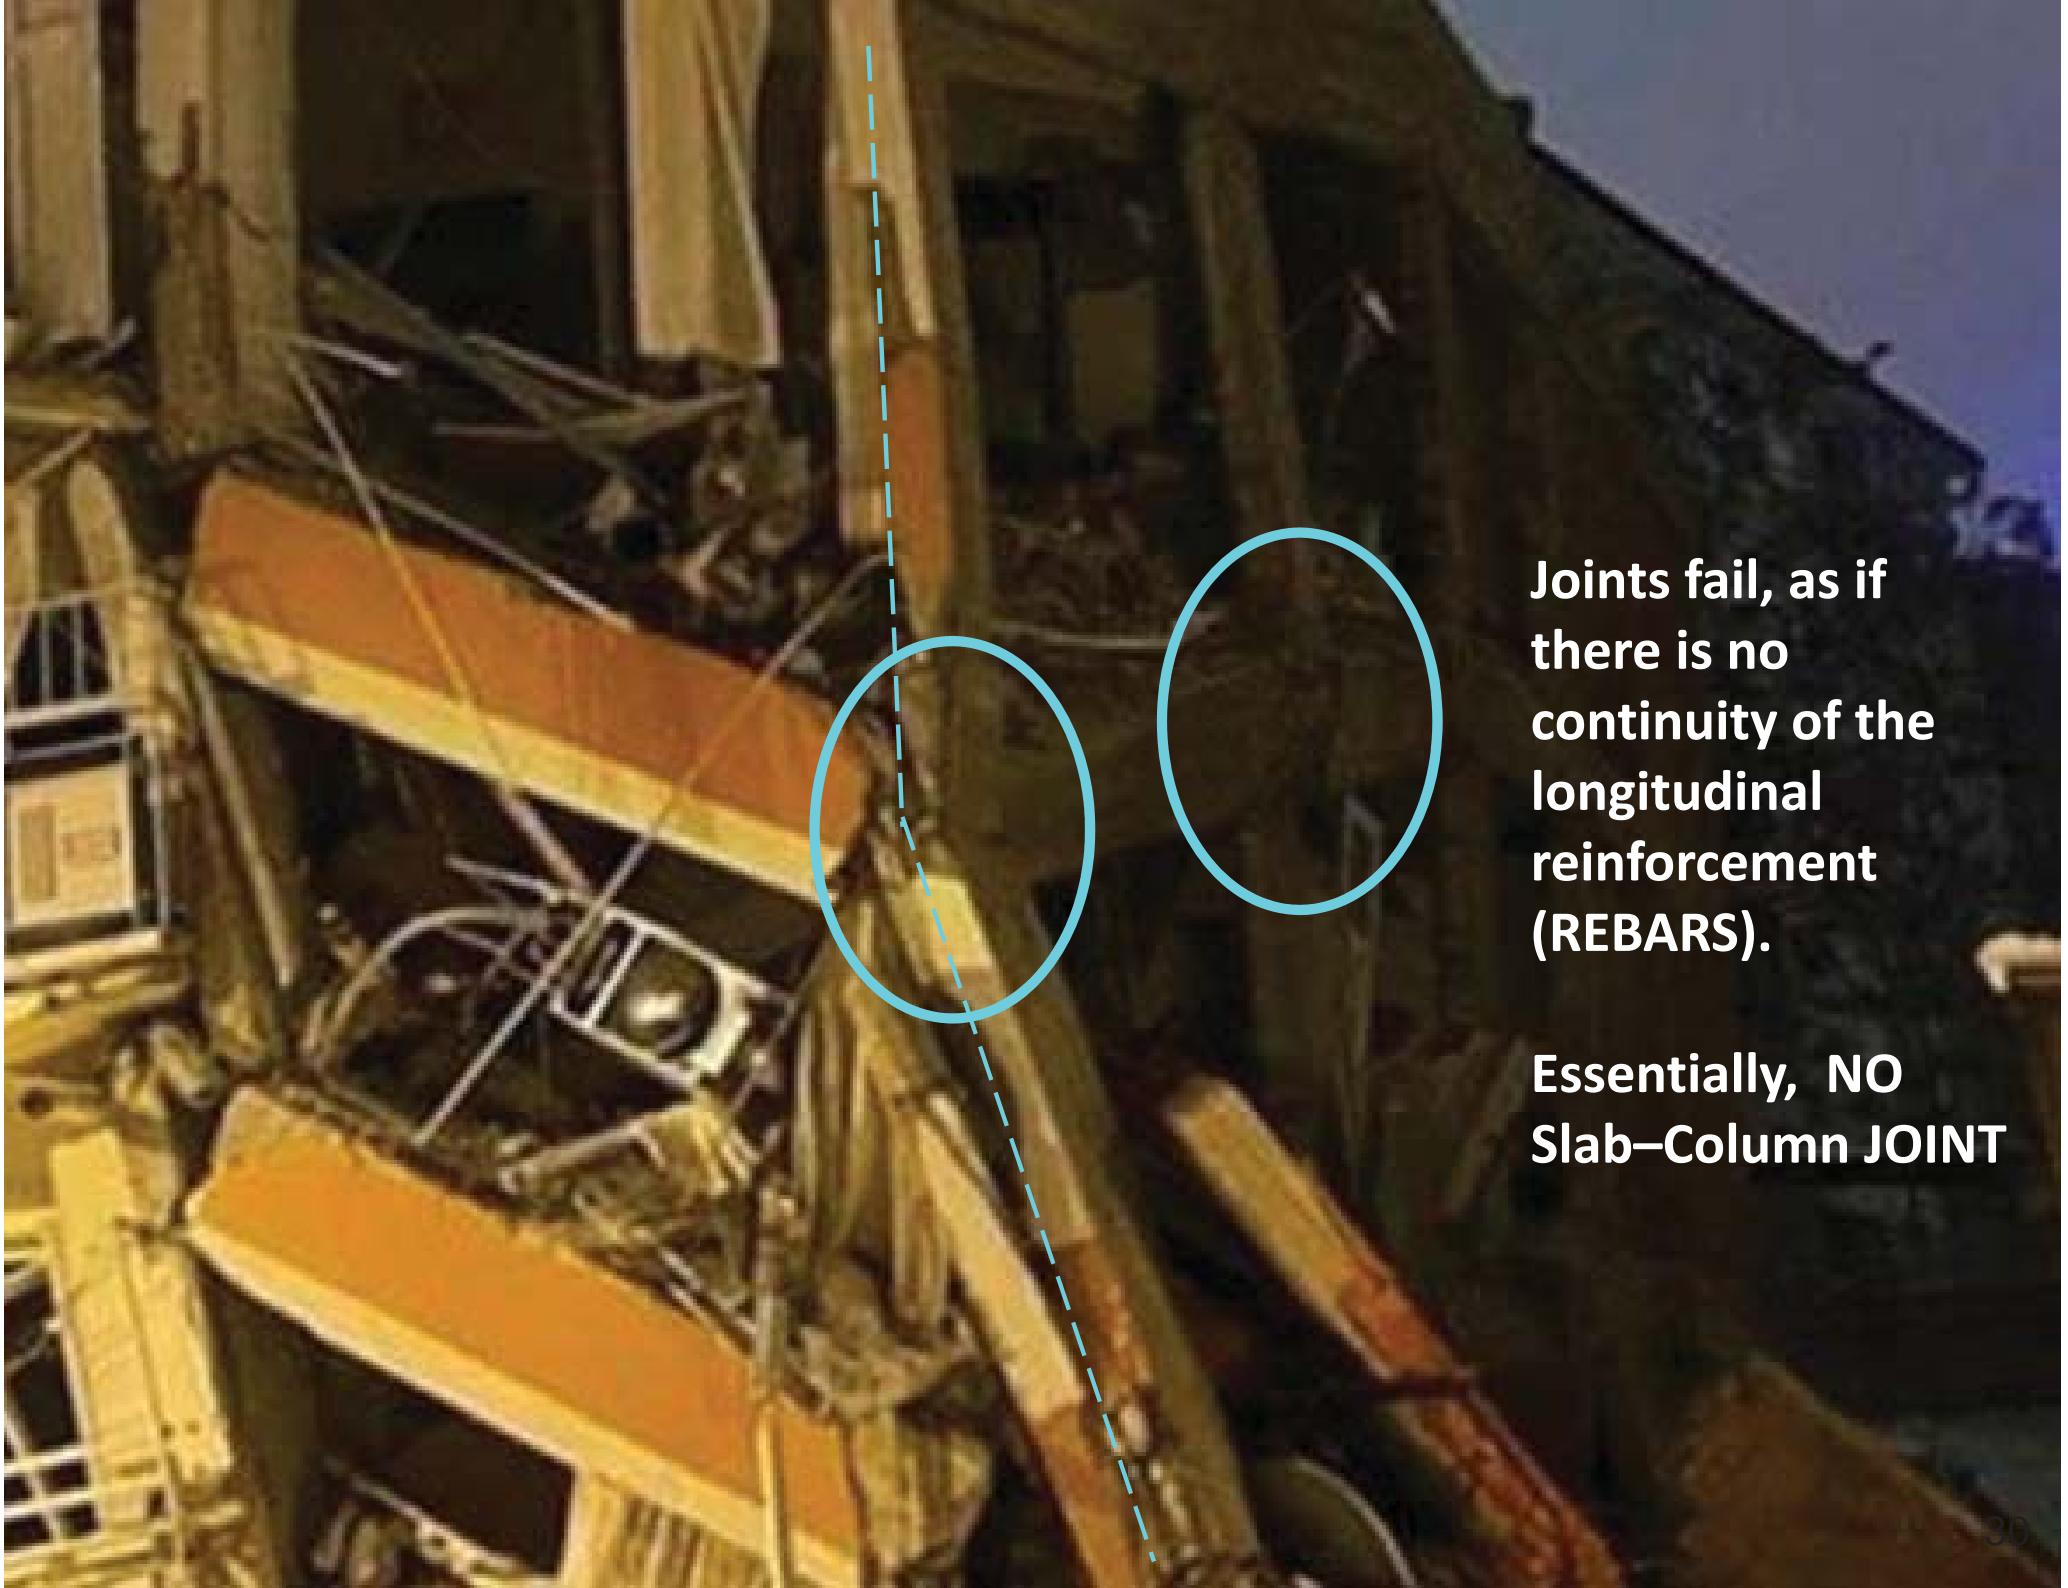
**Joints fail, as if
there is no
continuity of the
longitudinal
reinforcement
(REBARS).**

**Essentially, NO
Slab–Column JOINT**

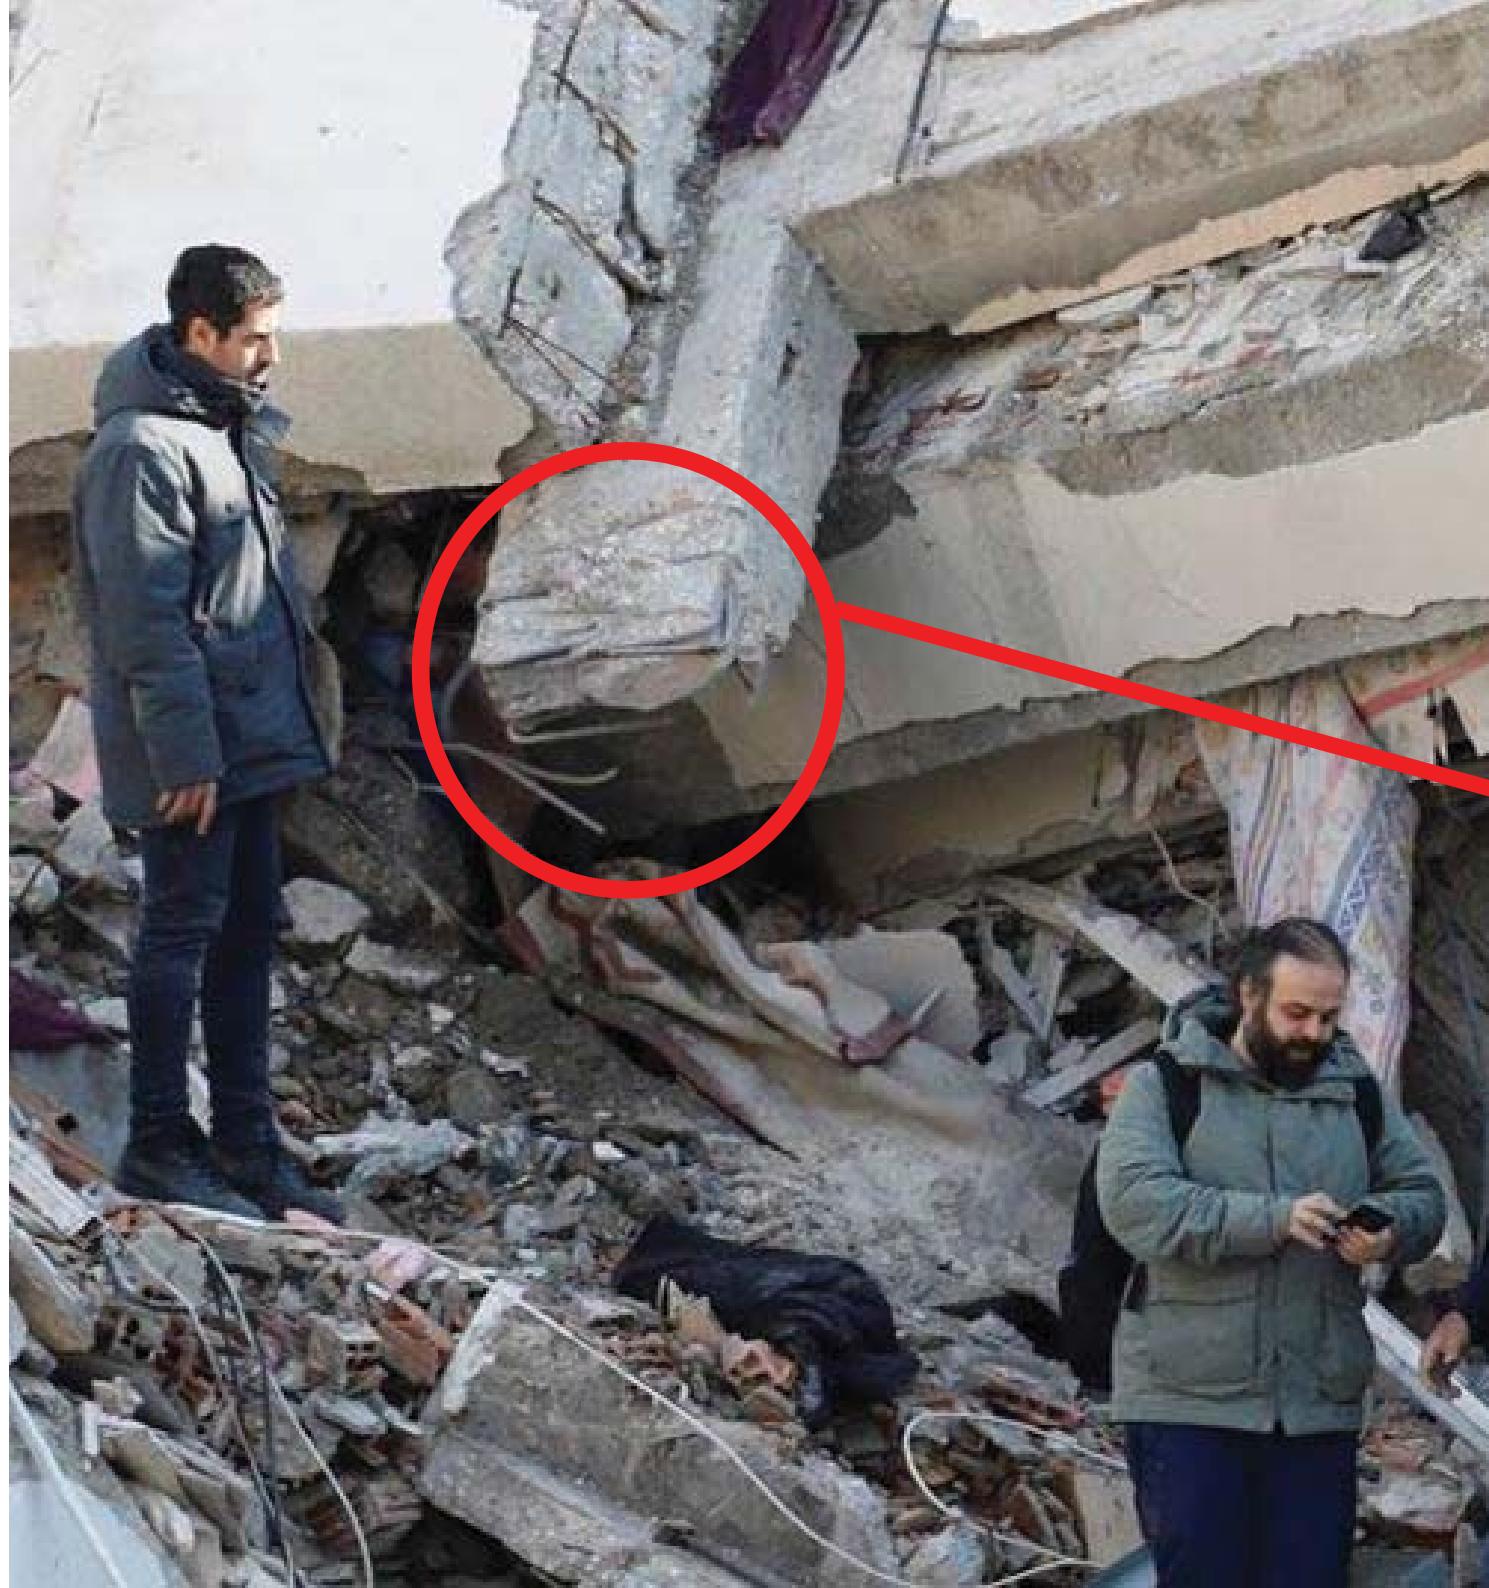
**VERY FEW REBARS,
OF VERY SMALL
DIAMETER**

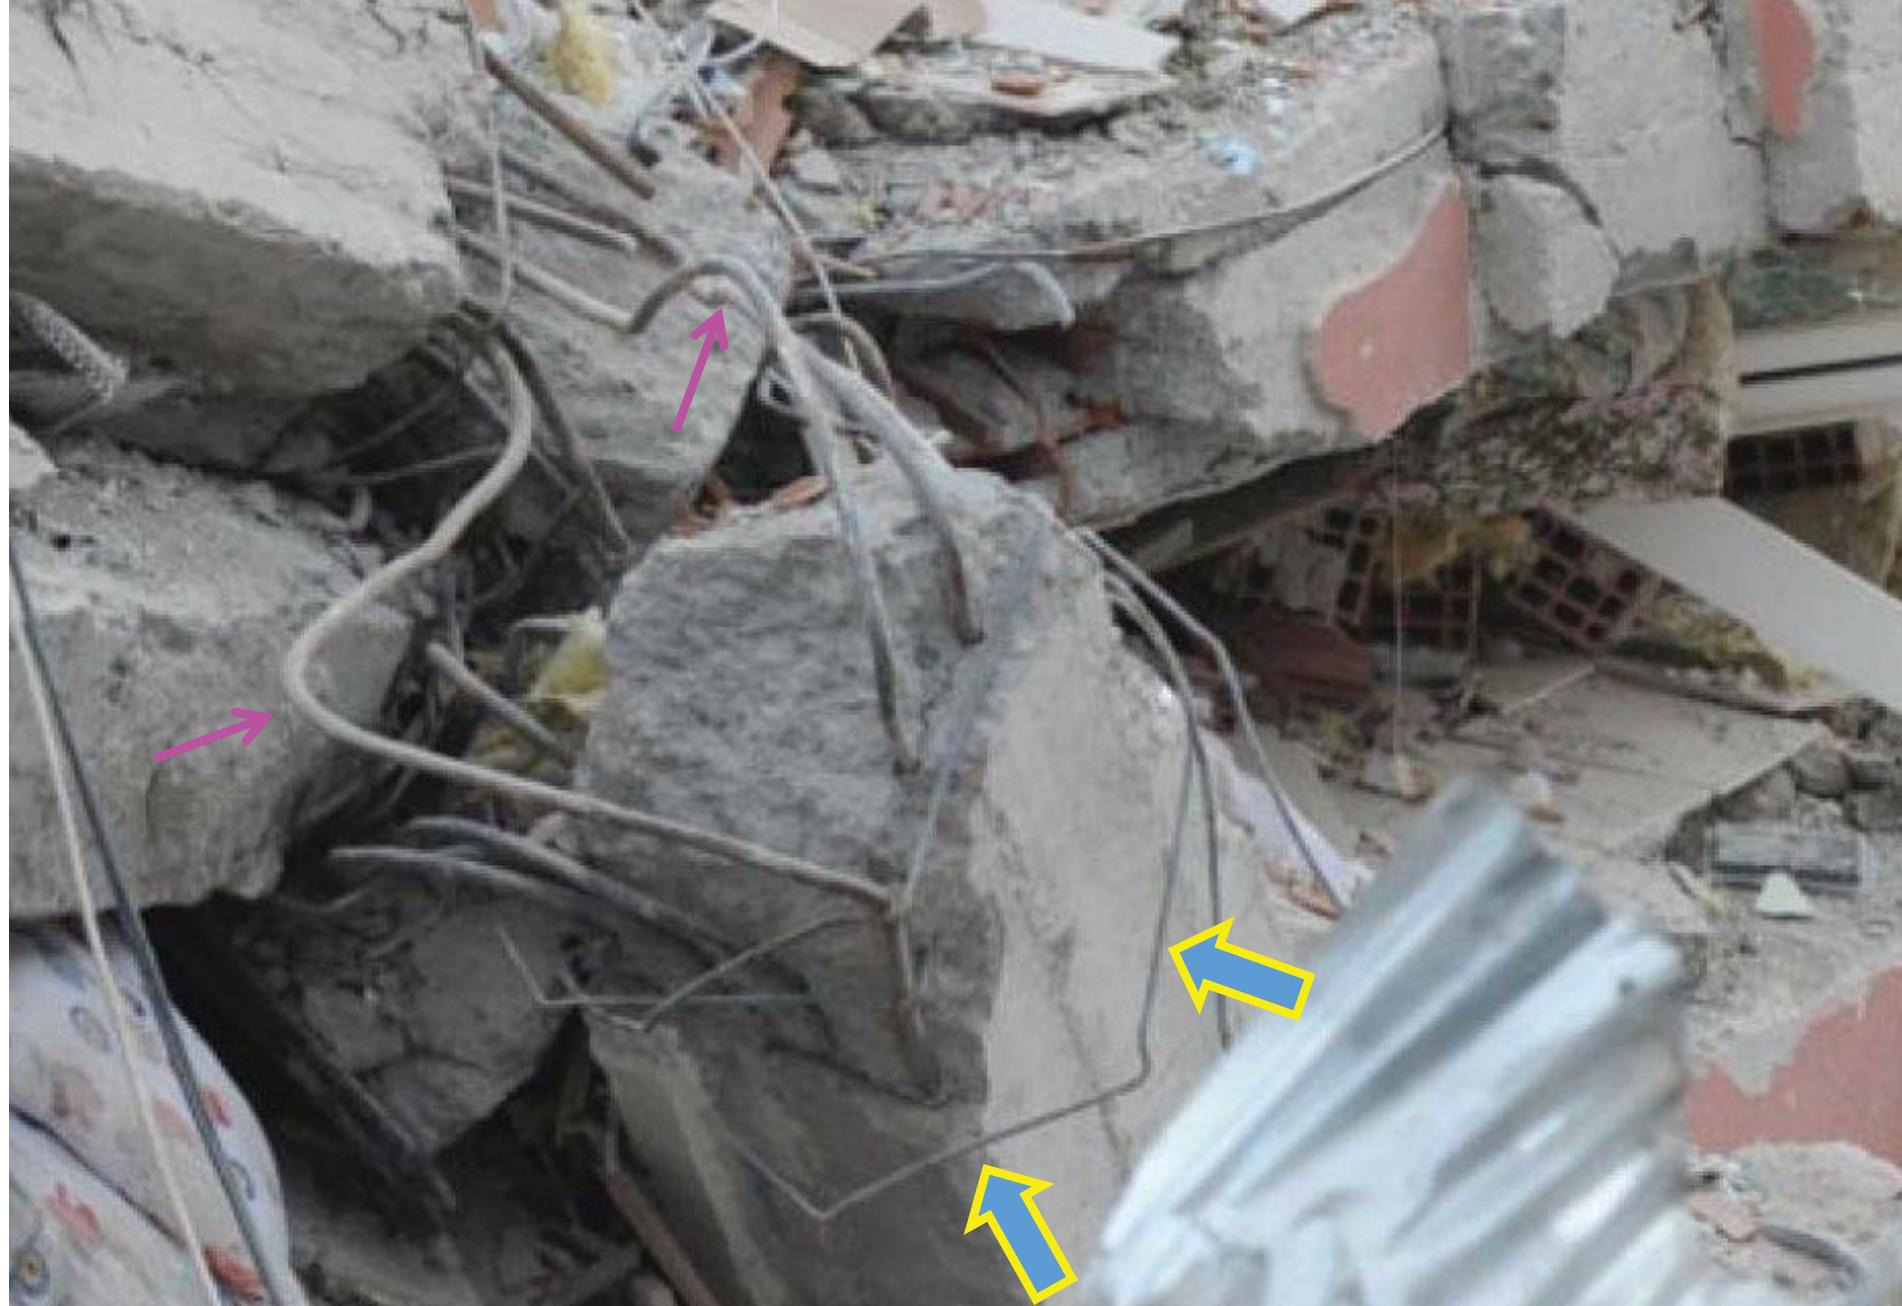
Transverse reinforcement almost effectively non-existing... it was untied, leading the inadequate longitudinal rebars to buckle.

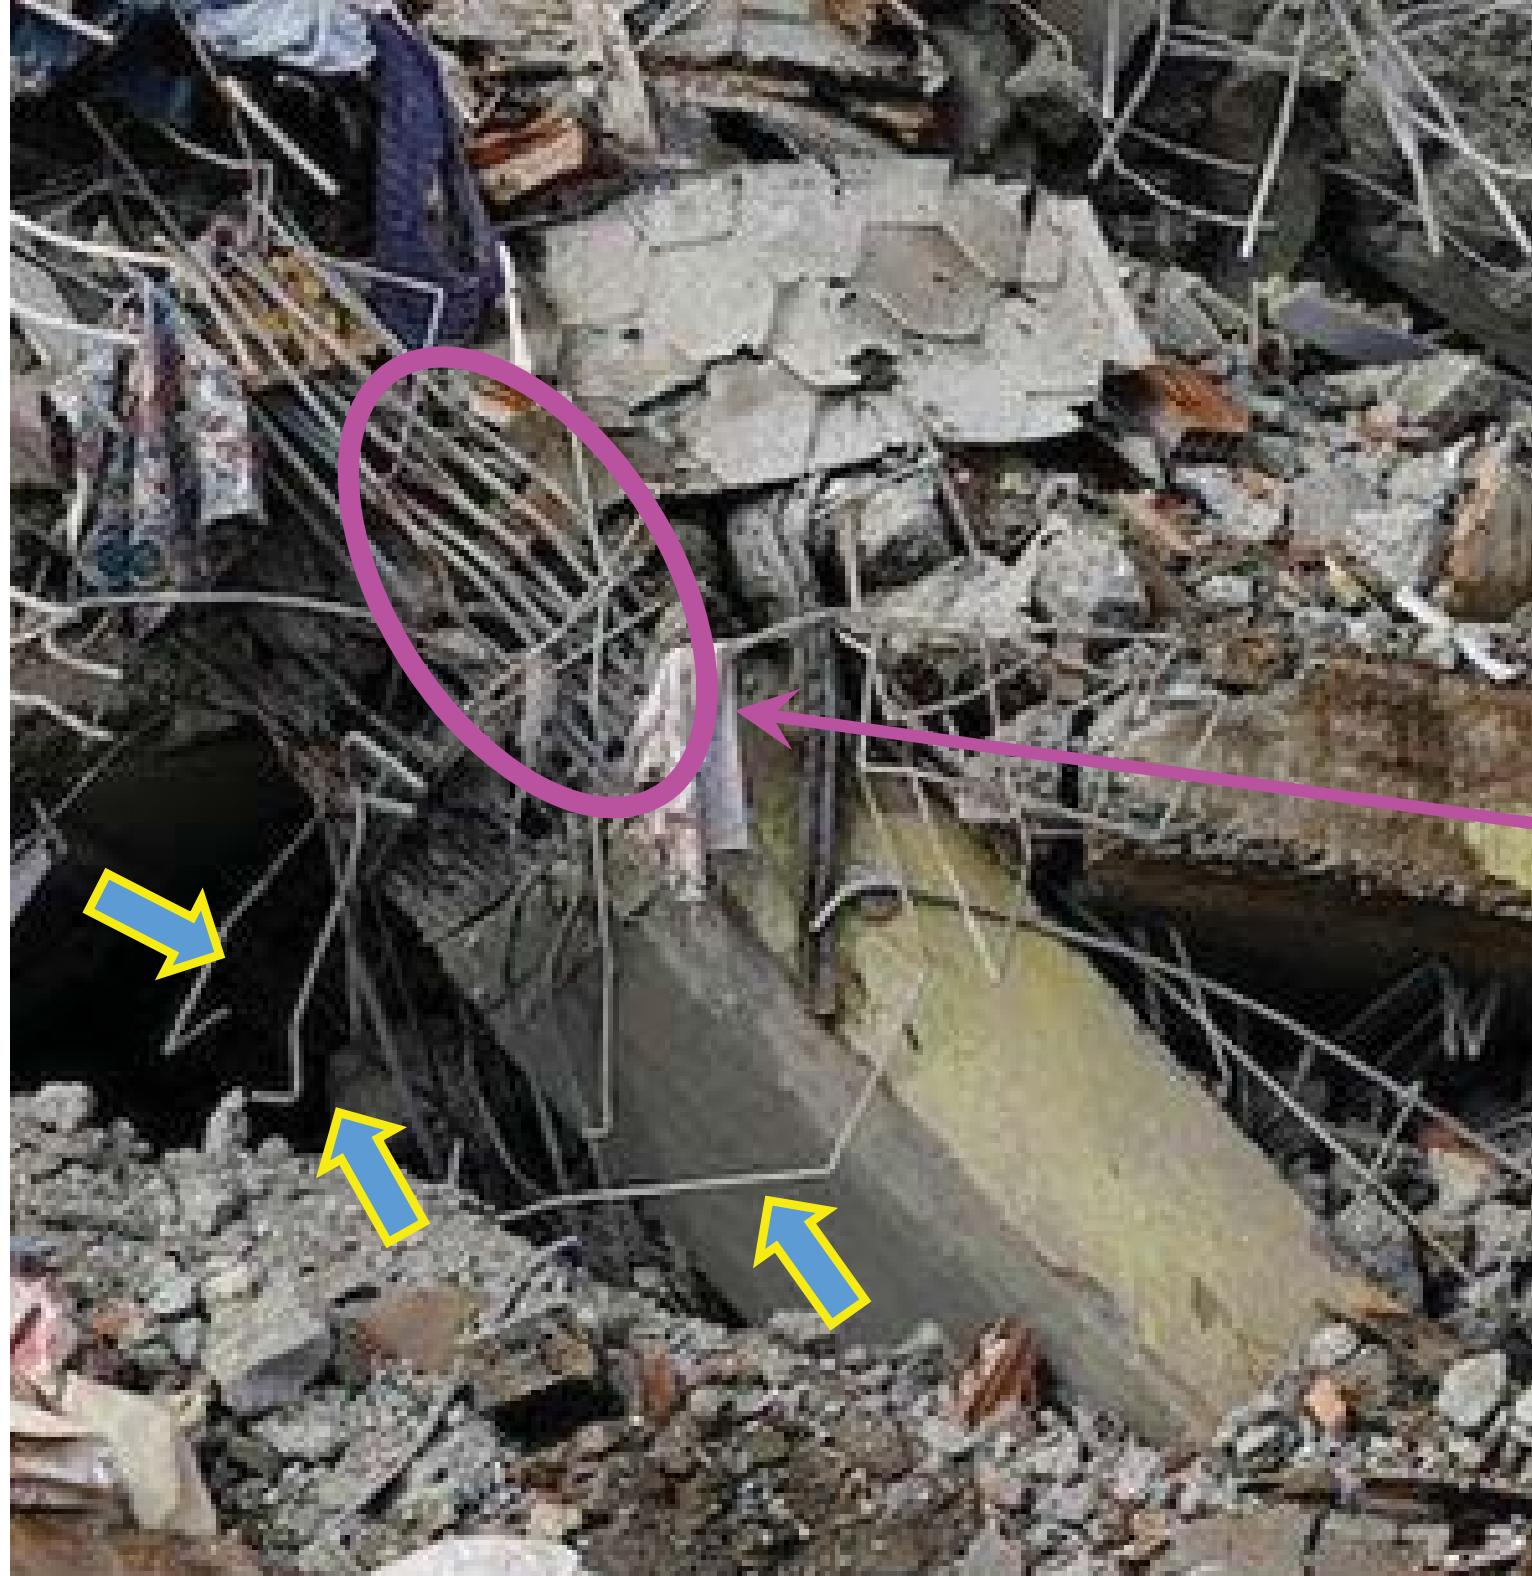
**Transverse bars
were un-tied.**

**Longitudinal
REBARS are of
VERY SMALL
DIAMETER**

**NO BEAMS, POOR (or rather No)
JOINTS !**
