The 2 earthquakes of February 6th 2023 in Turkey

PRELIMINARY REPORT

Failures of Multistorey Buildings

PART B: Structural Collapse and Interpretation

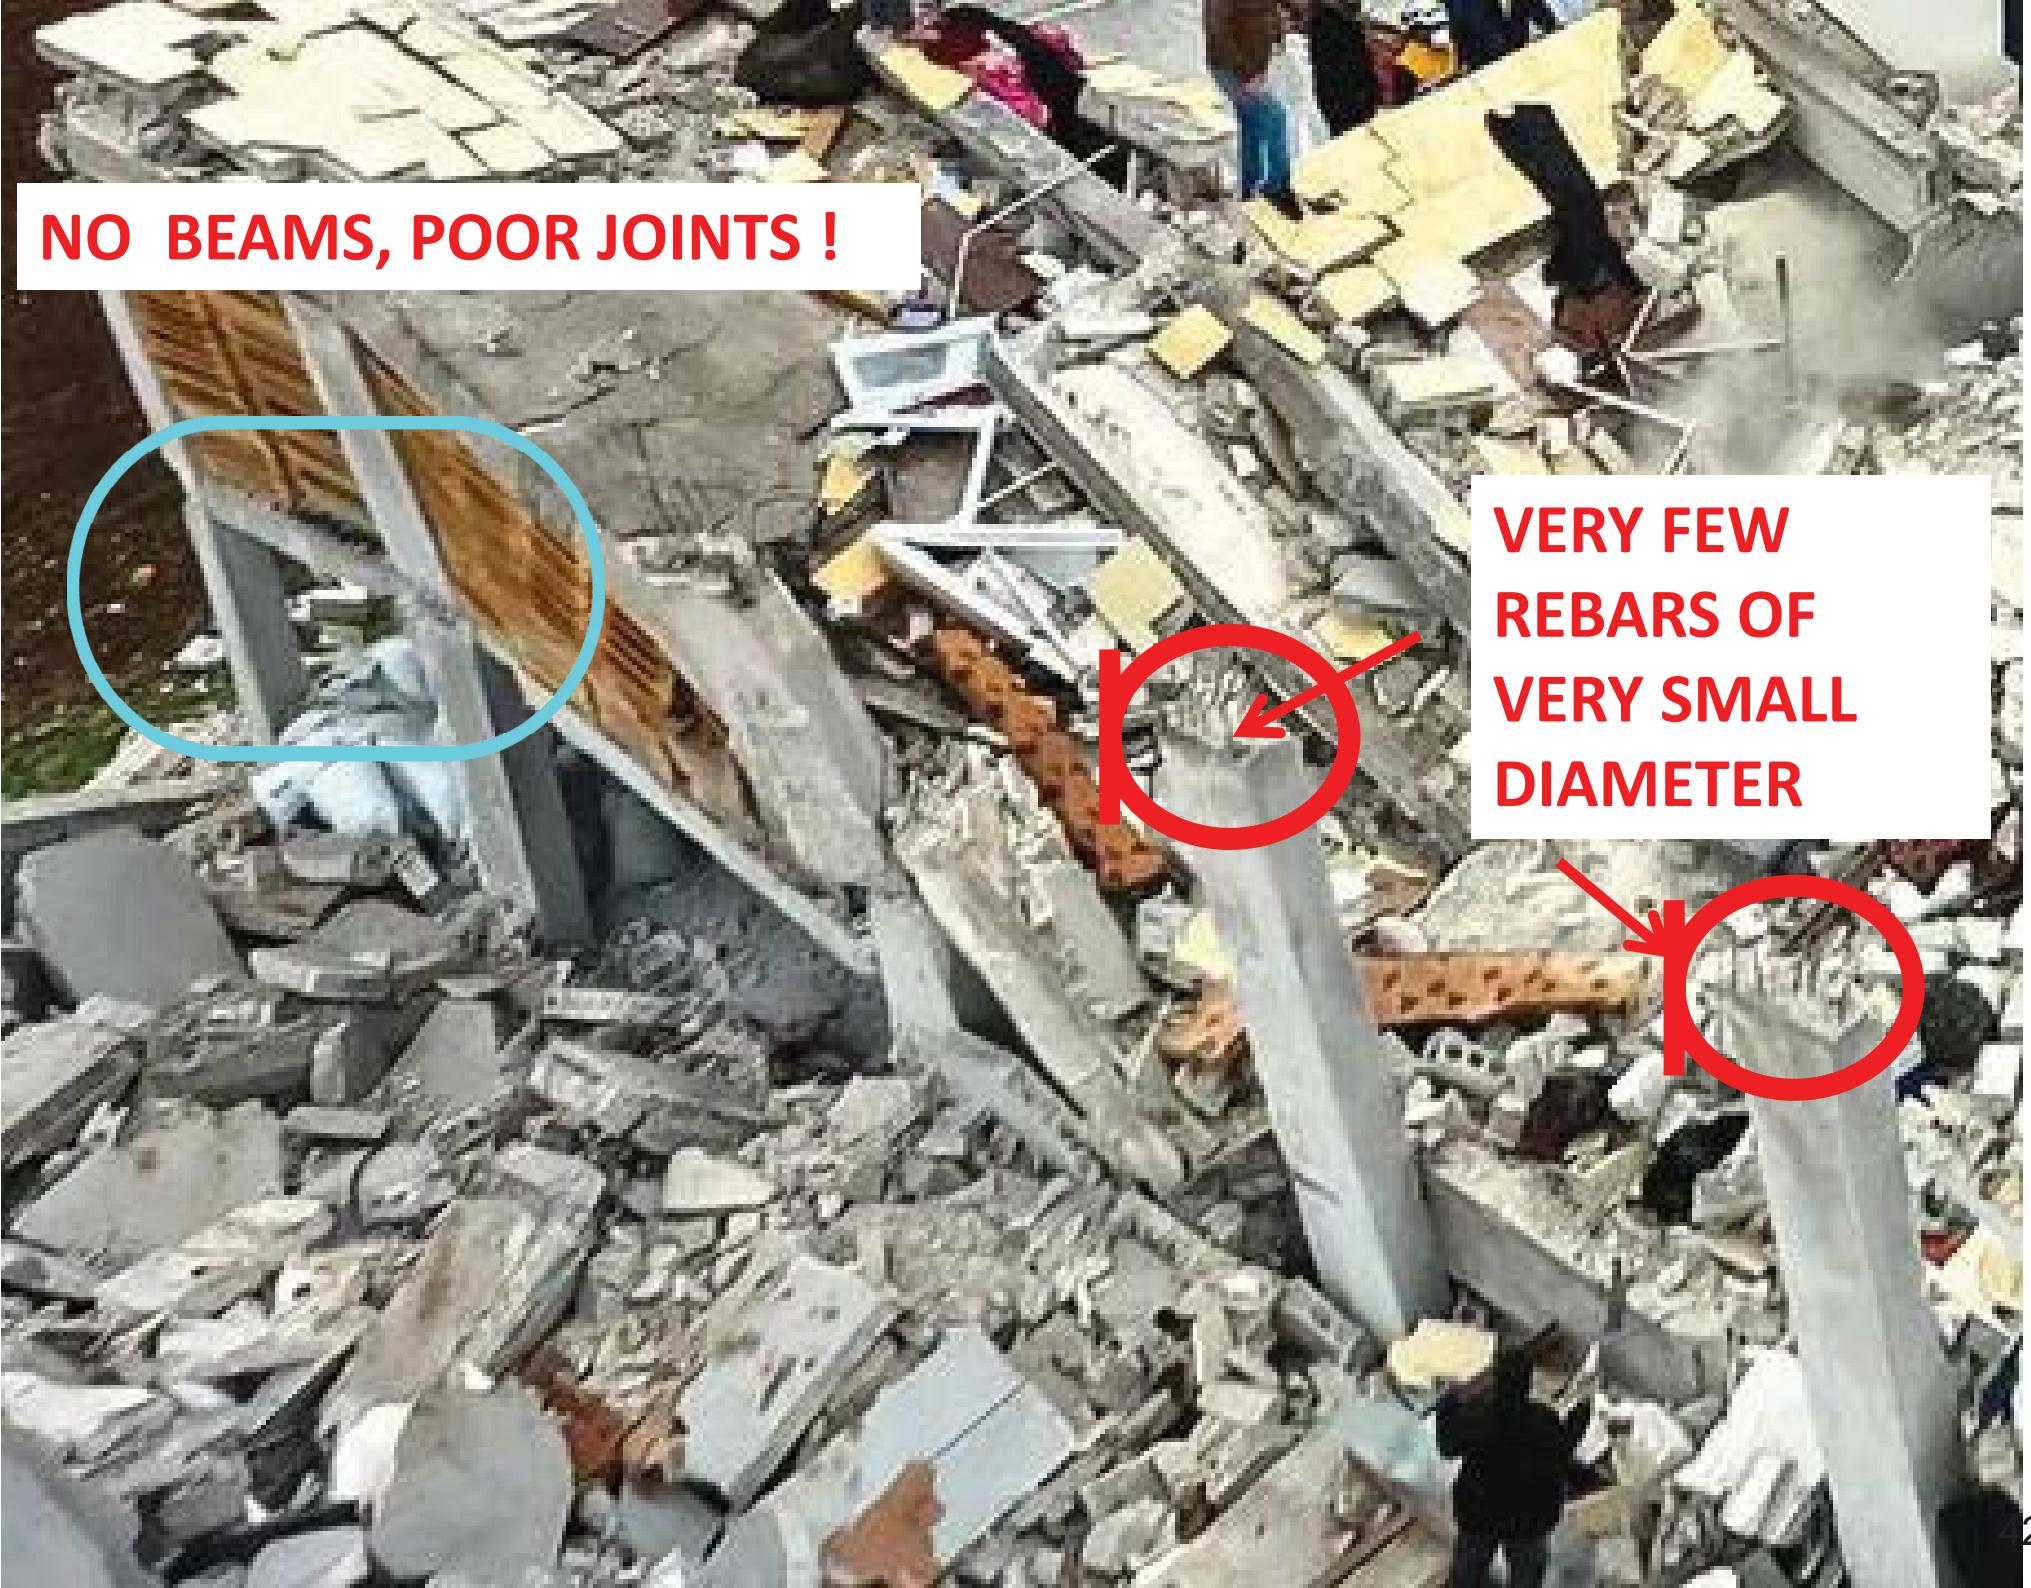
NO BEAMS, POOR JOINTS !

VERY FEW
REBARS OF
VERY SMALL
DIAMETER

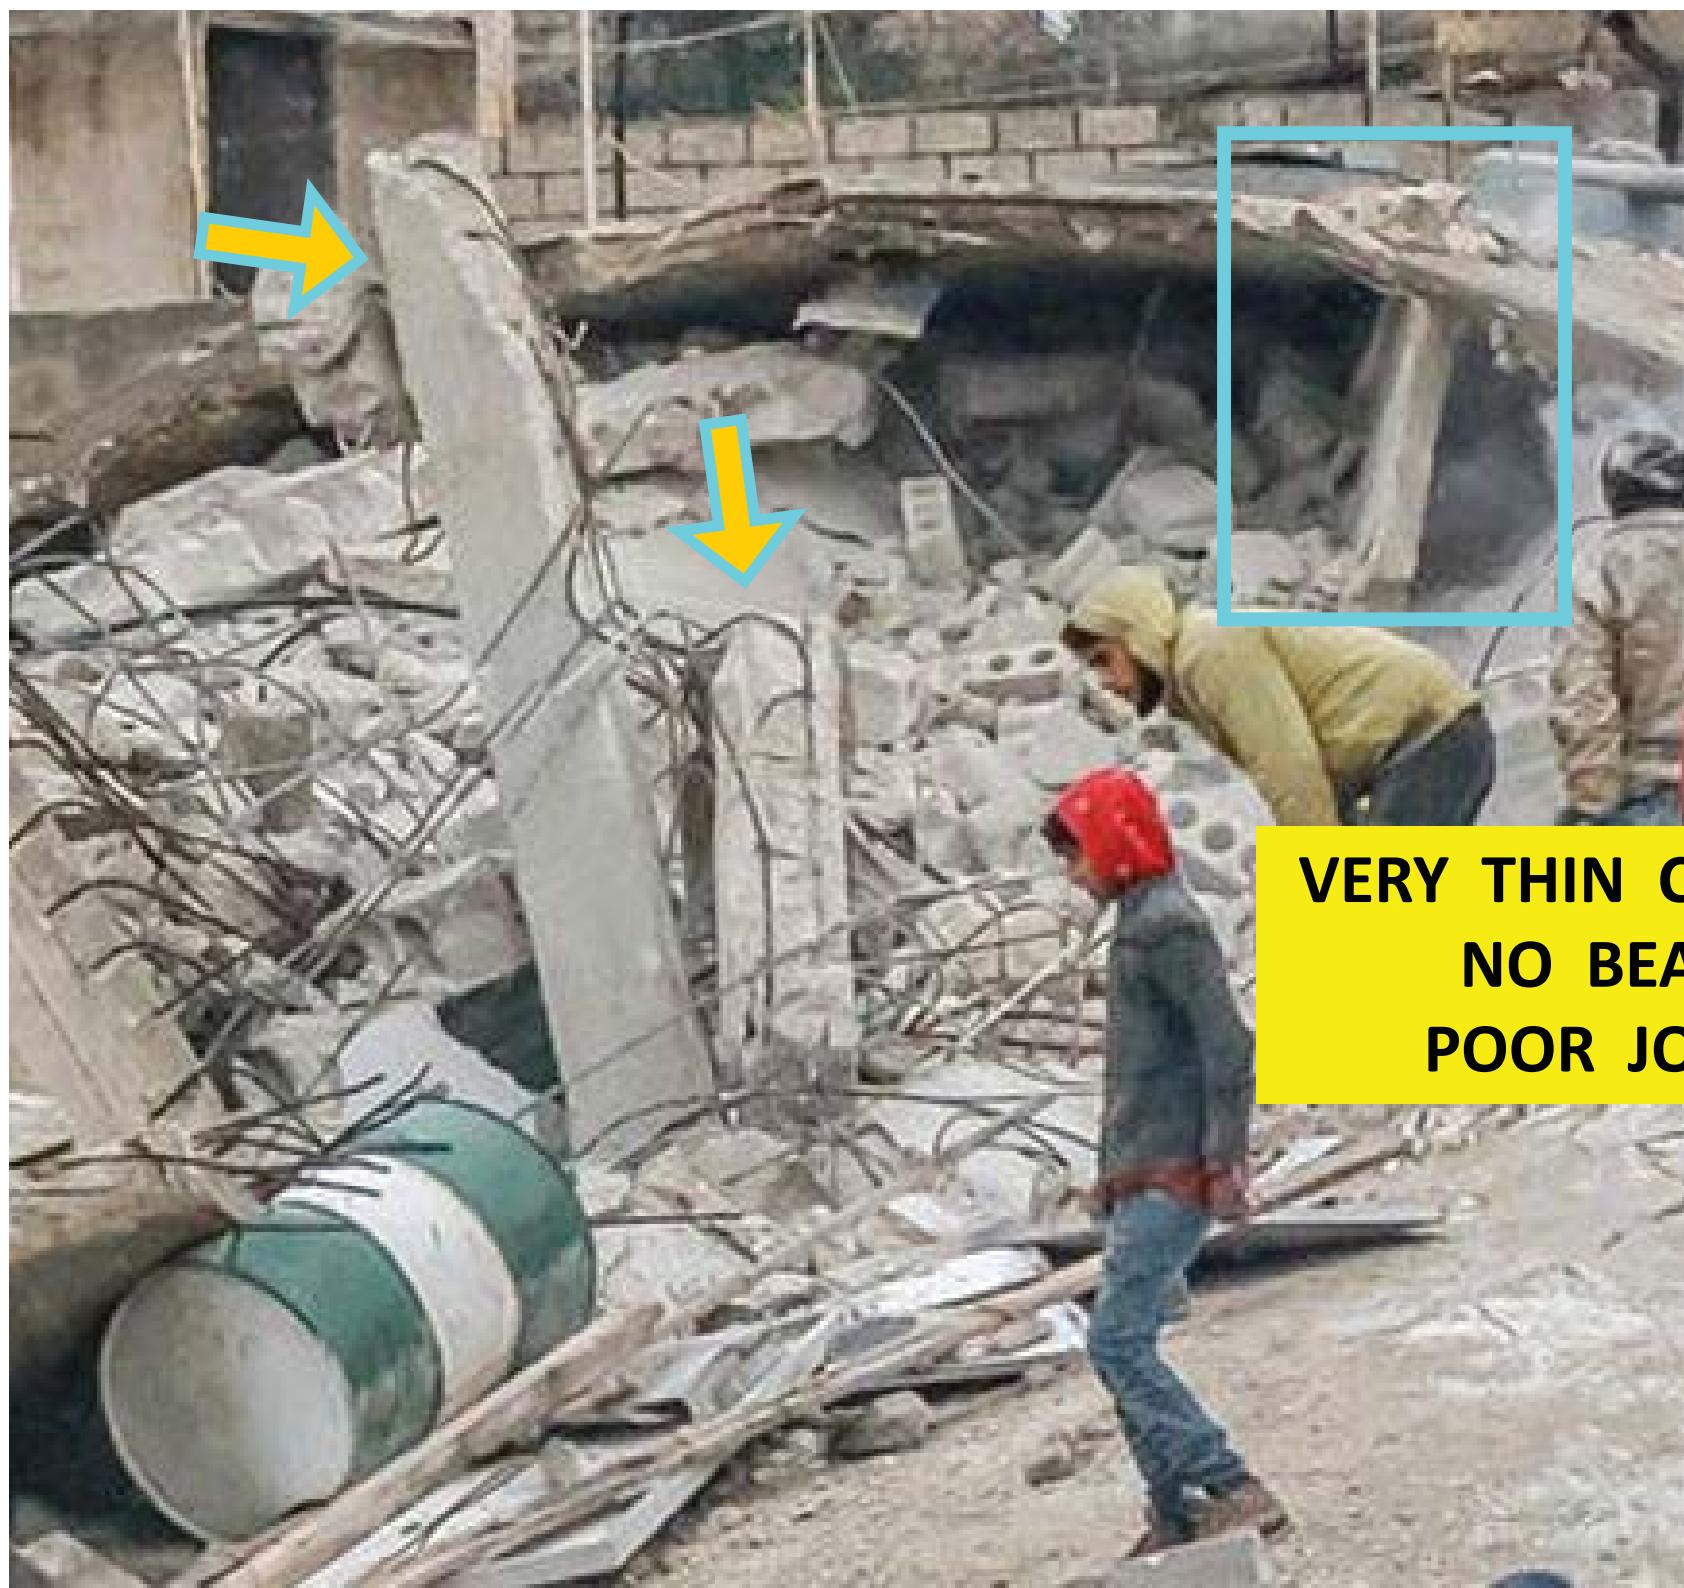
**VERY THIN COLUMNS
NO BEAMS
POOR JOINTS**

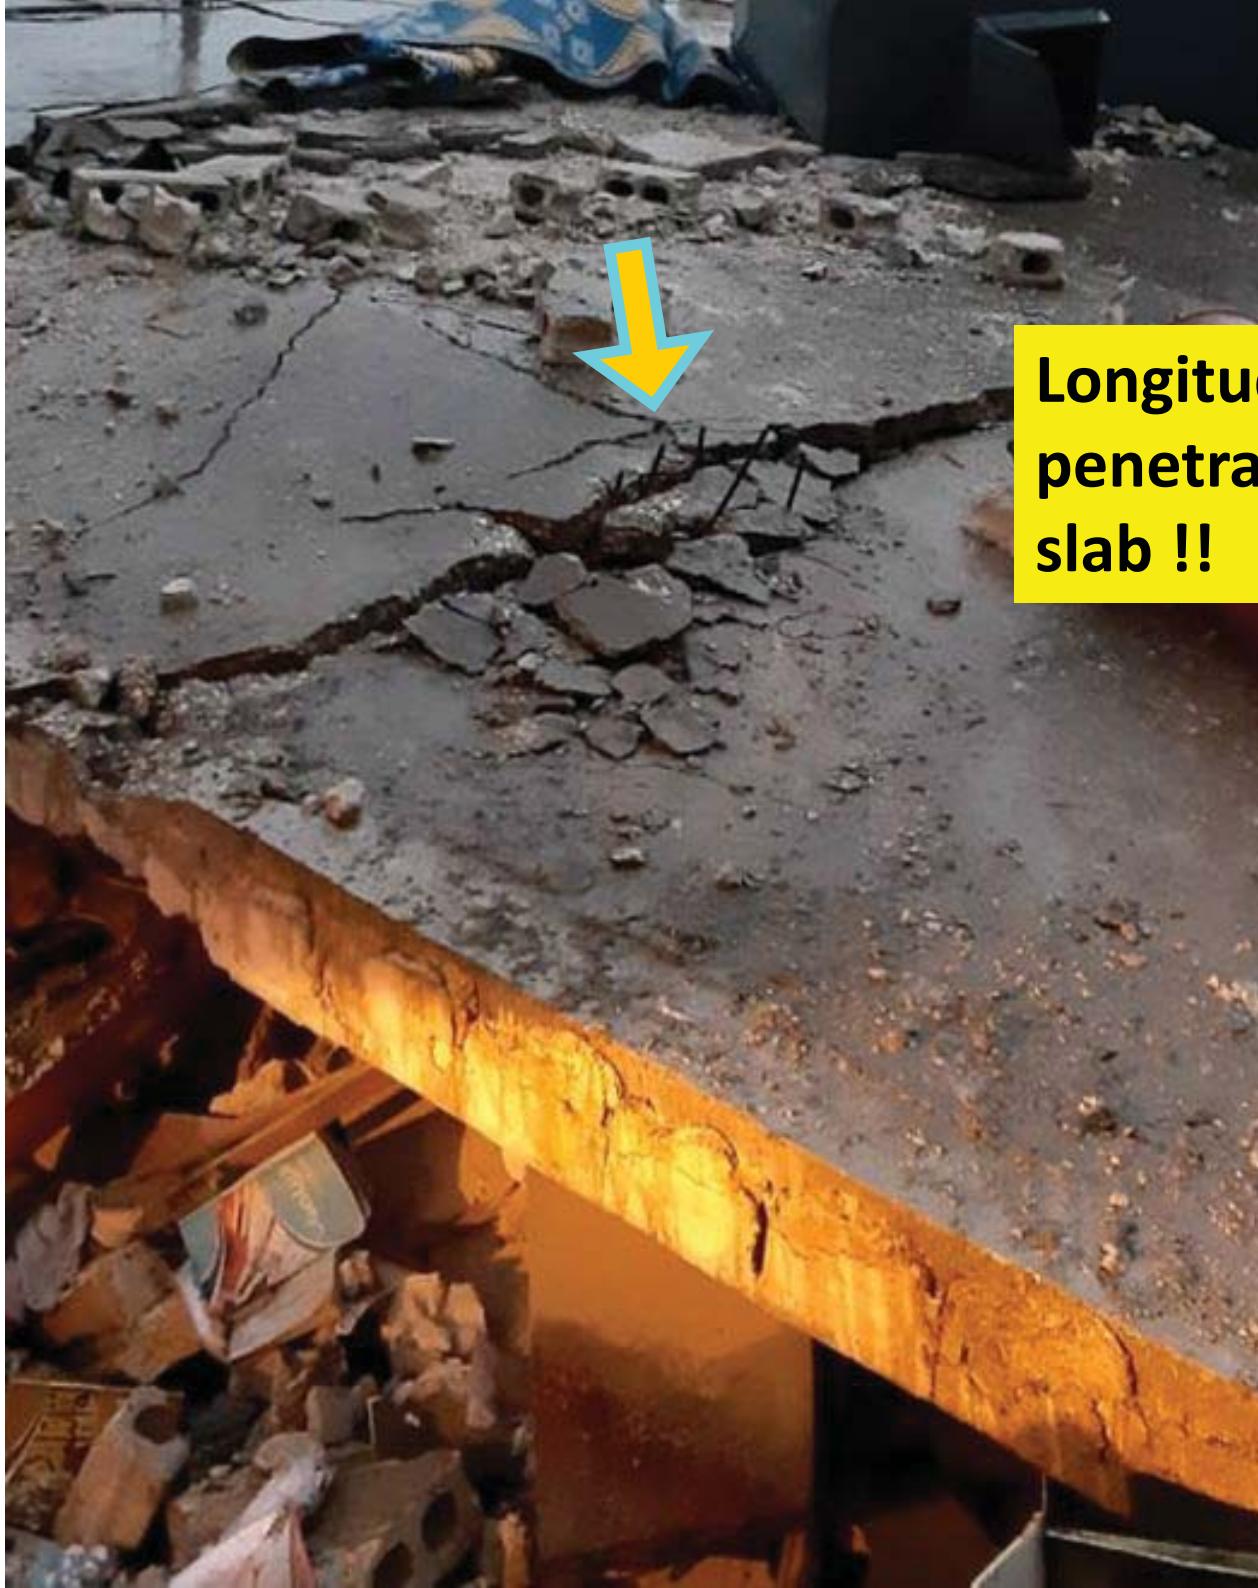
Longitudinal REBARS have penetrated the supported slab !!

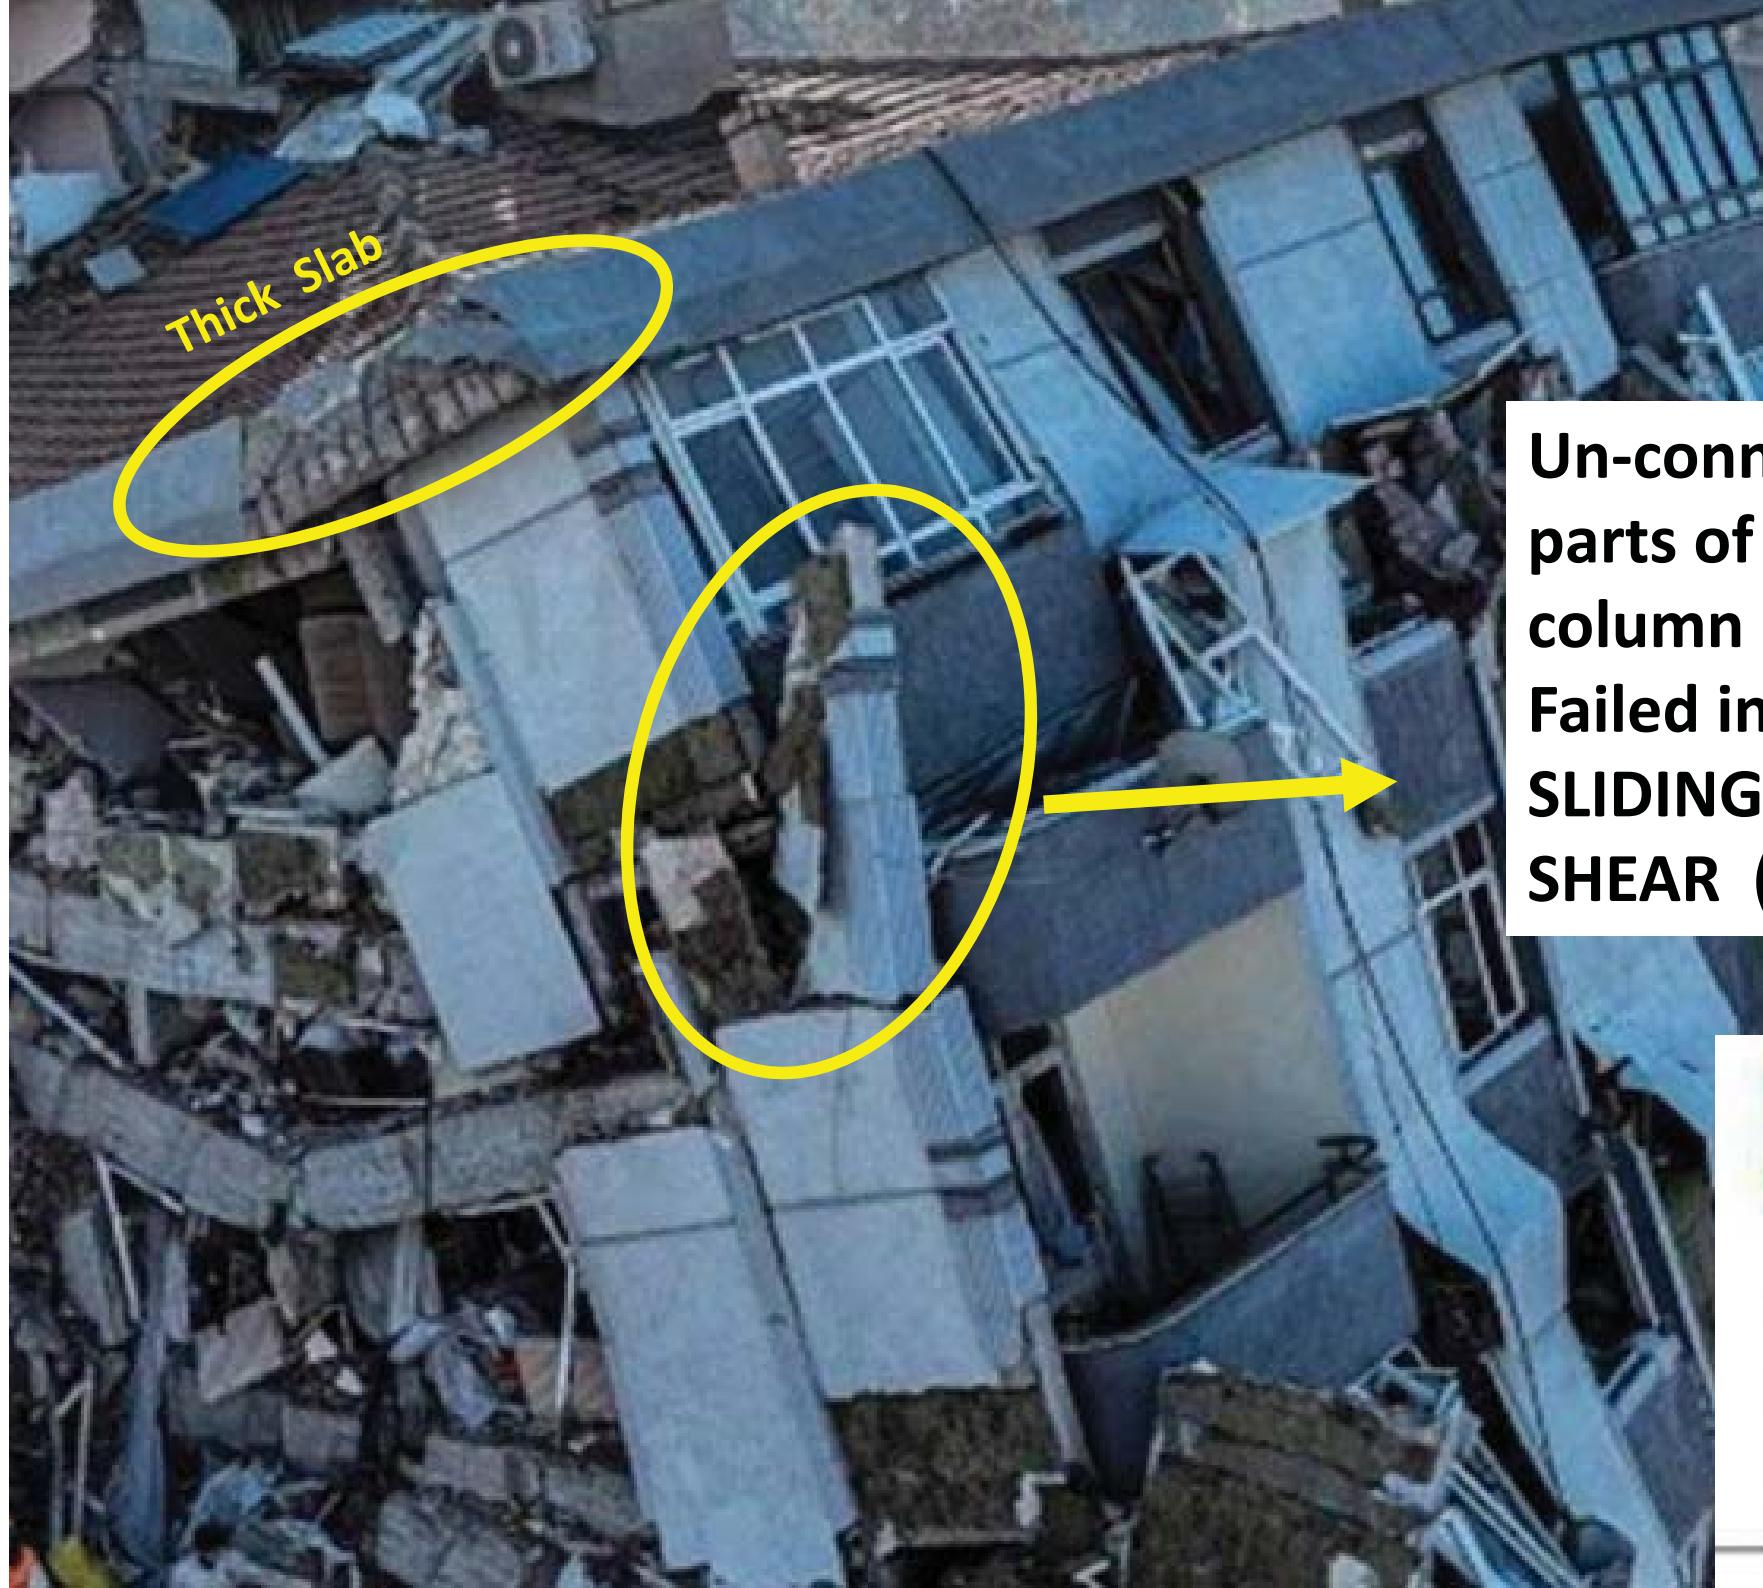
NO BEAMS, NO JOINTS, NO SHEAR WALLS

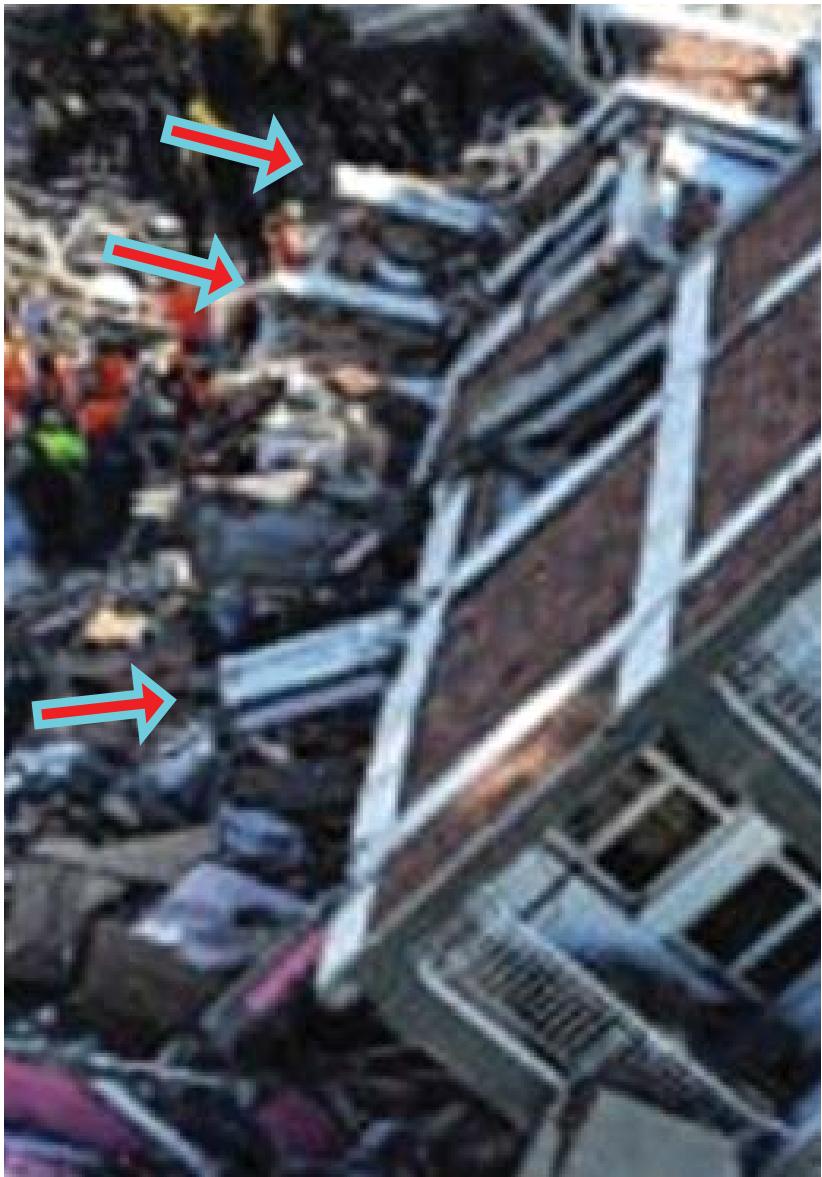
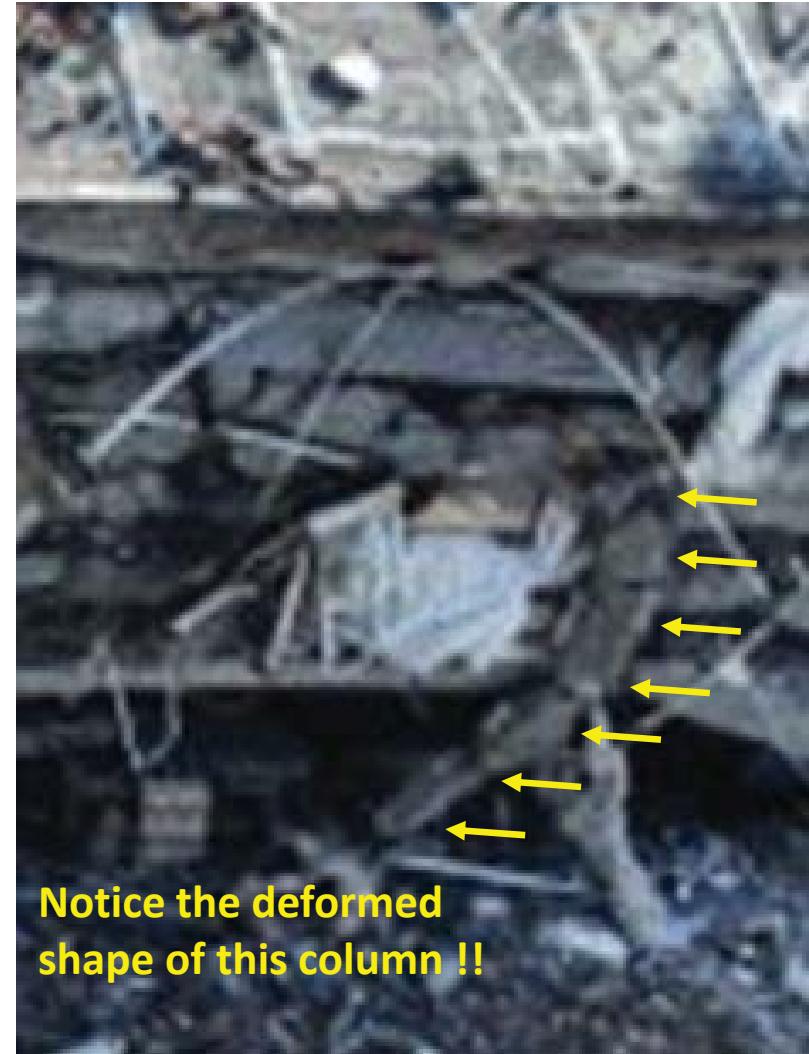
Notice the deformed shape of this column !!

Inadequate columns cannot “follow” the above building on its lateral movement

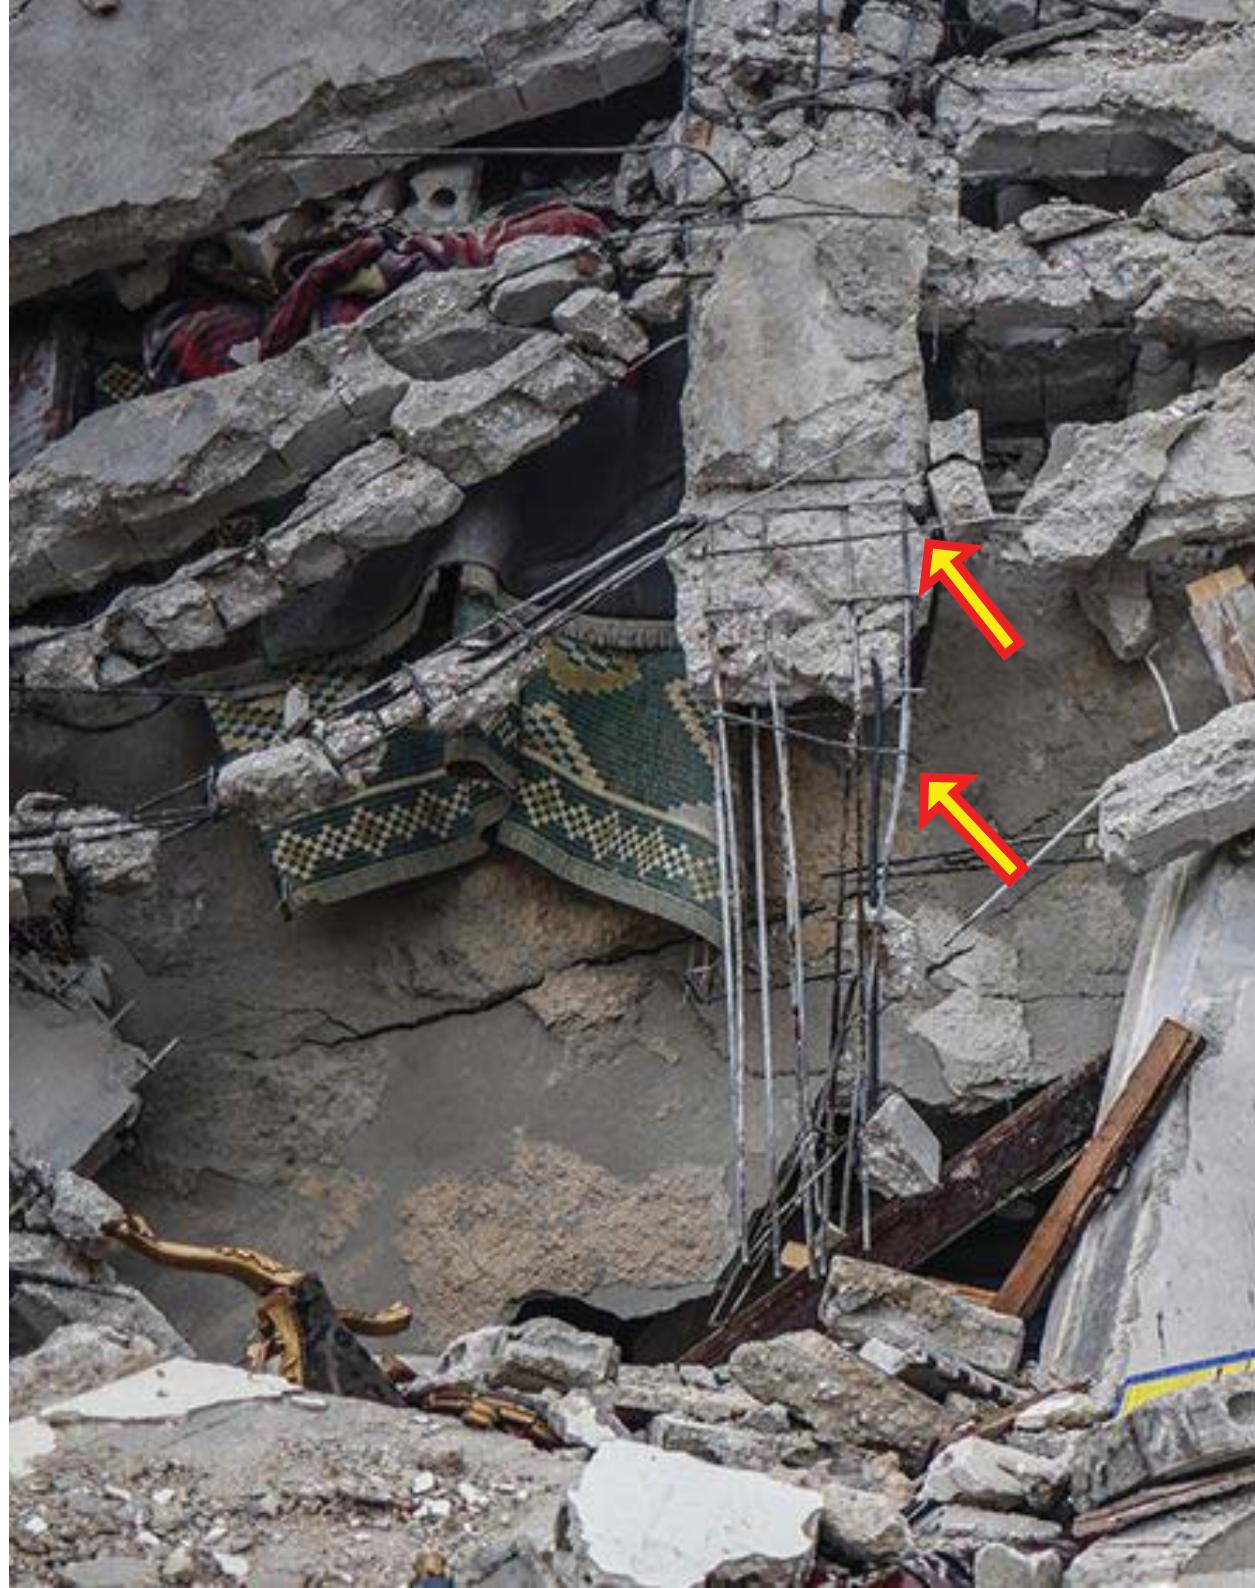
**FEW LONGITUDINAL REBARS,
OF VERY SMALL DIAMETER**

Transverse reinforcement ??
