# Some critical reasons for the collapse of a huge number of buildings

## PART C

### **Recorded Accelerograms and their Response Spectra**

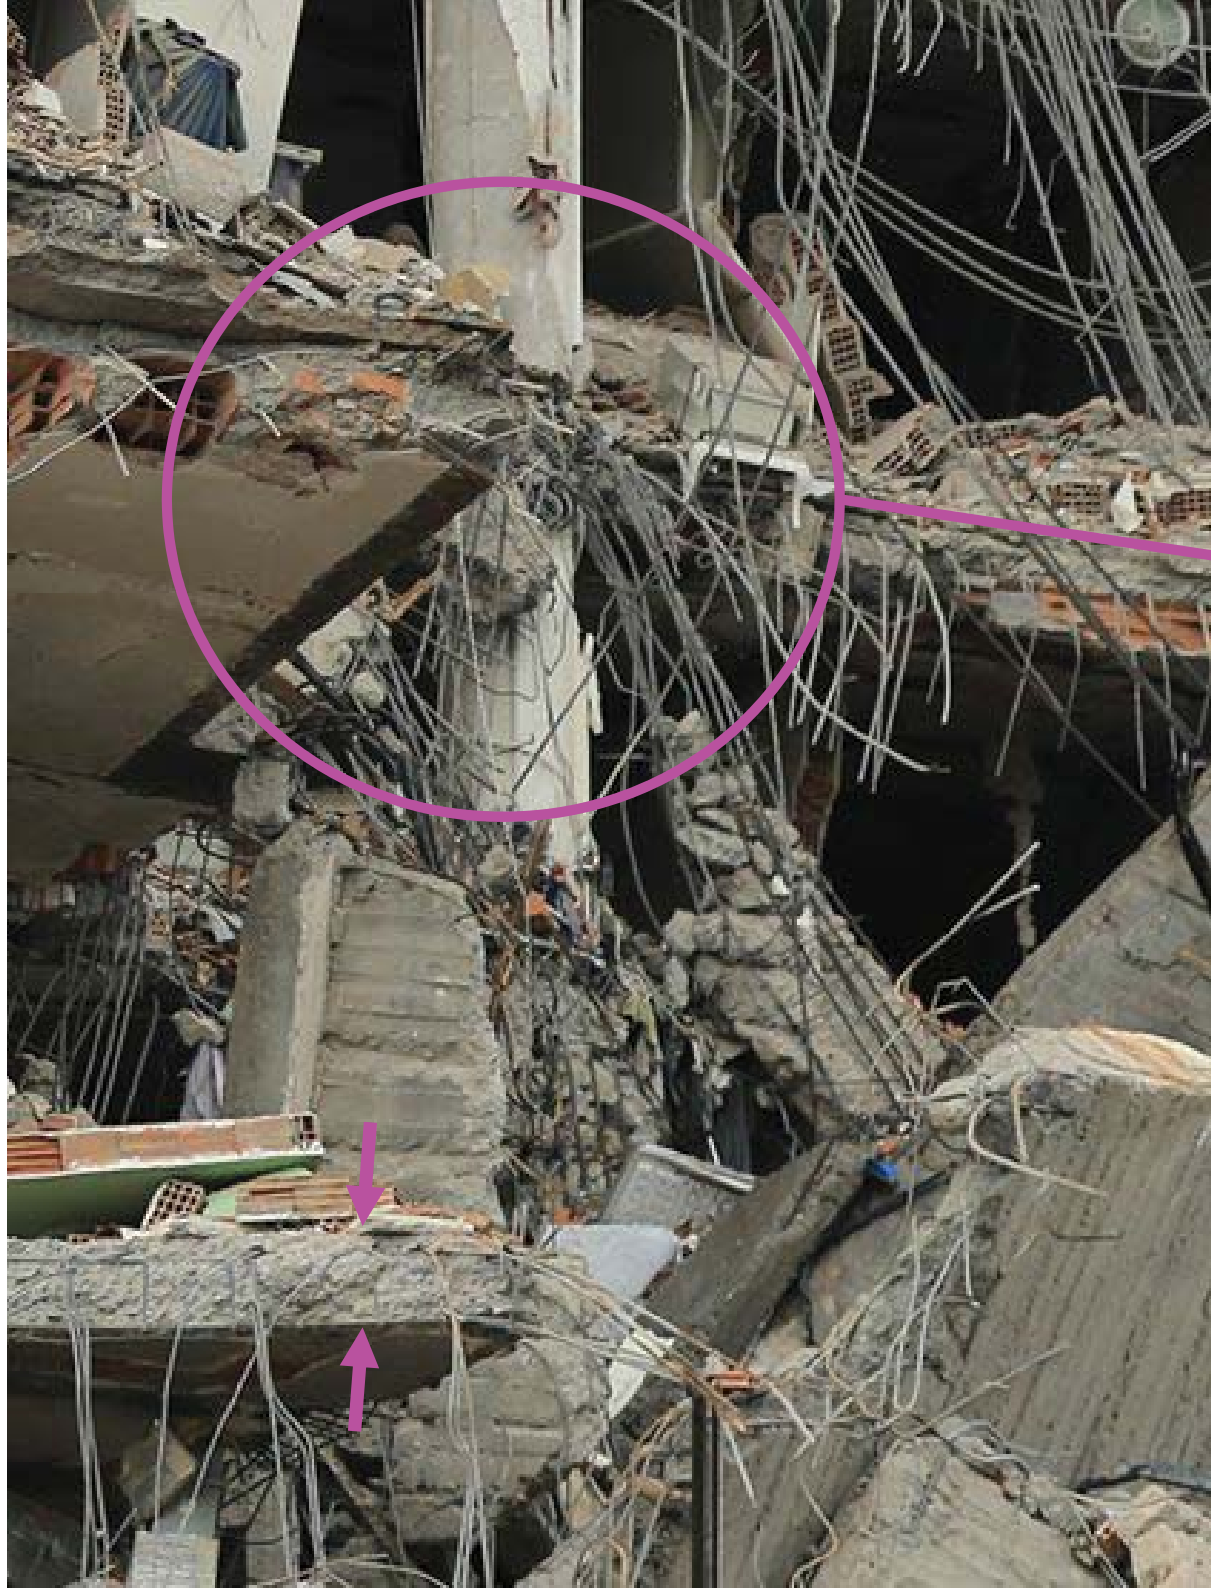
**NO BEAMS, POOR JOINTS !**

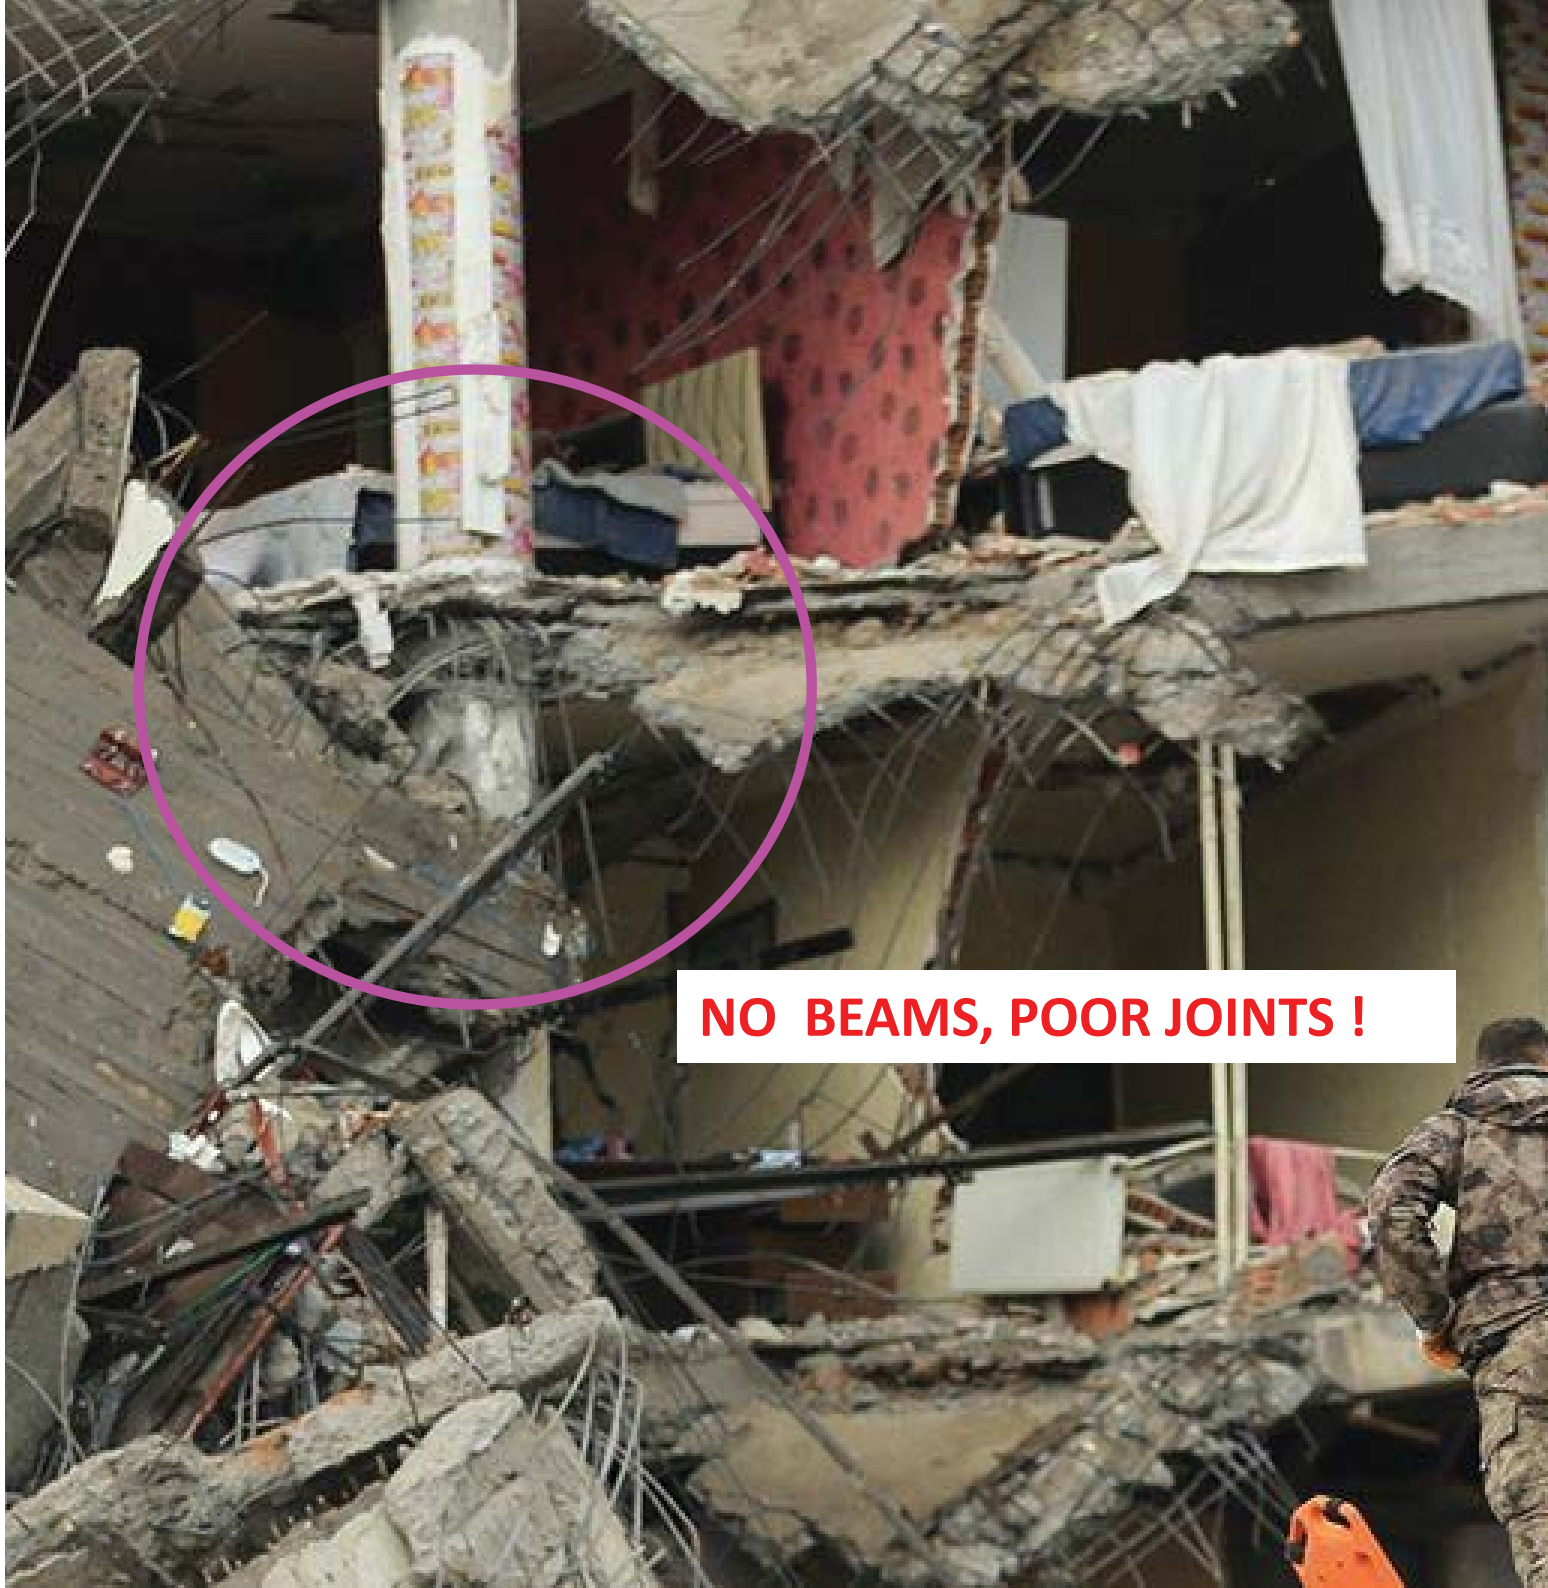
**NO BEAMS, POOR JOINTS !**

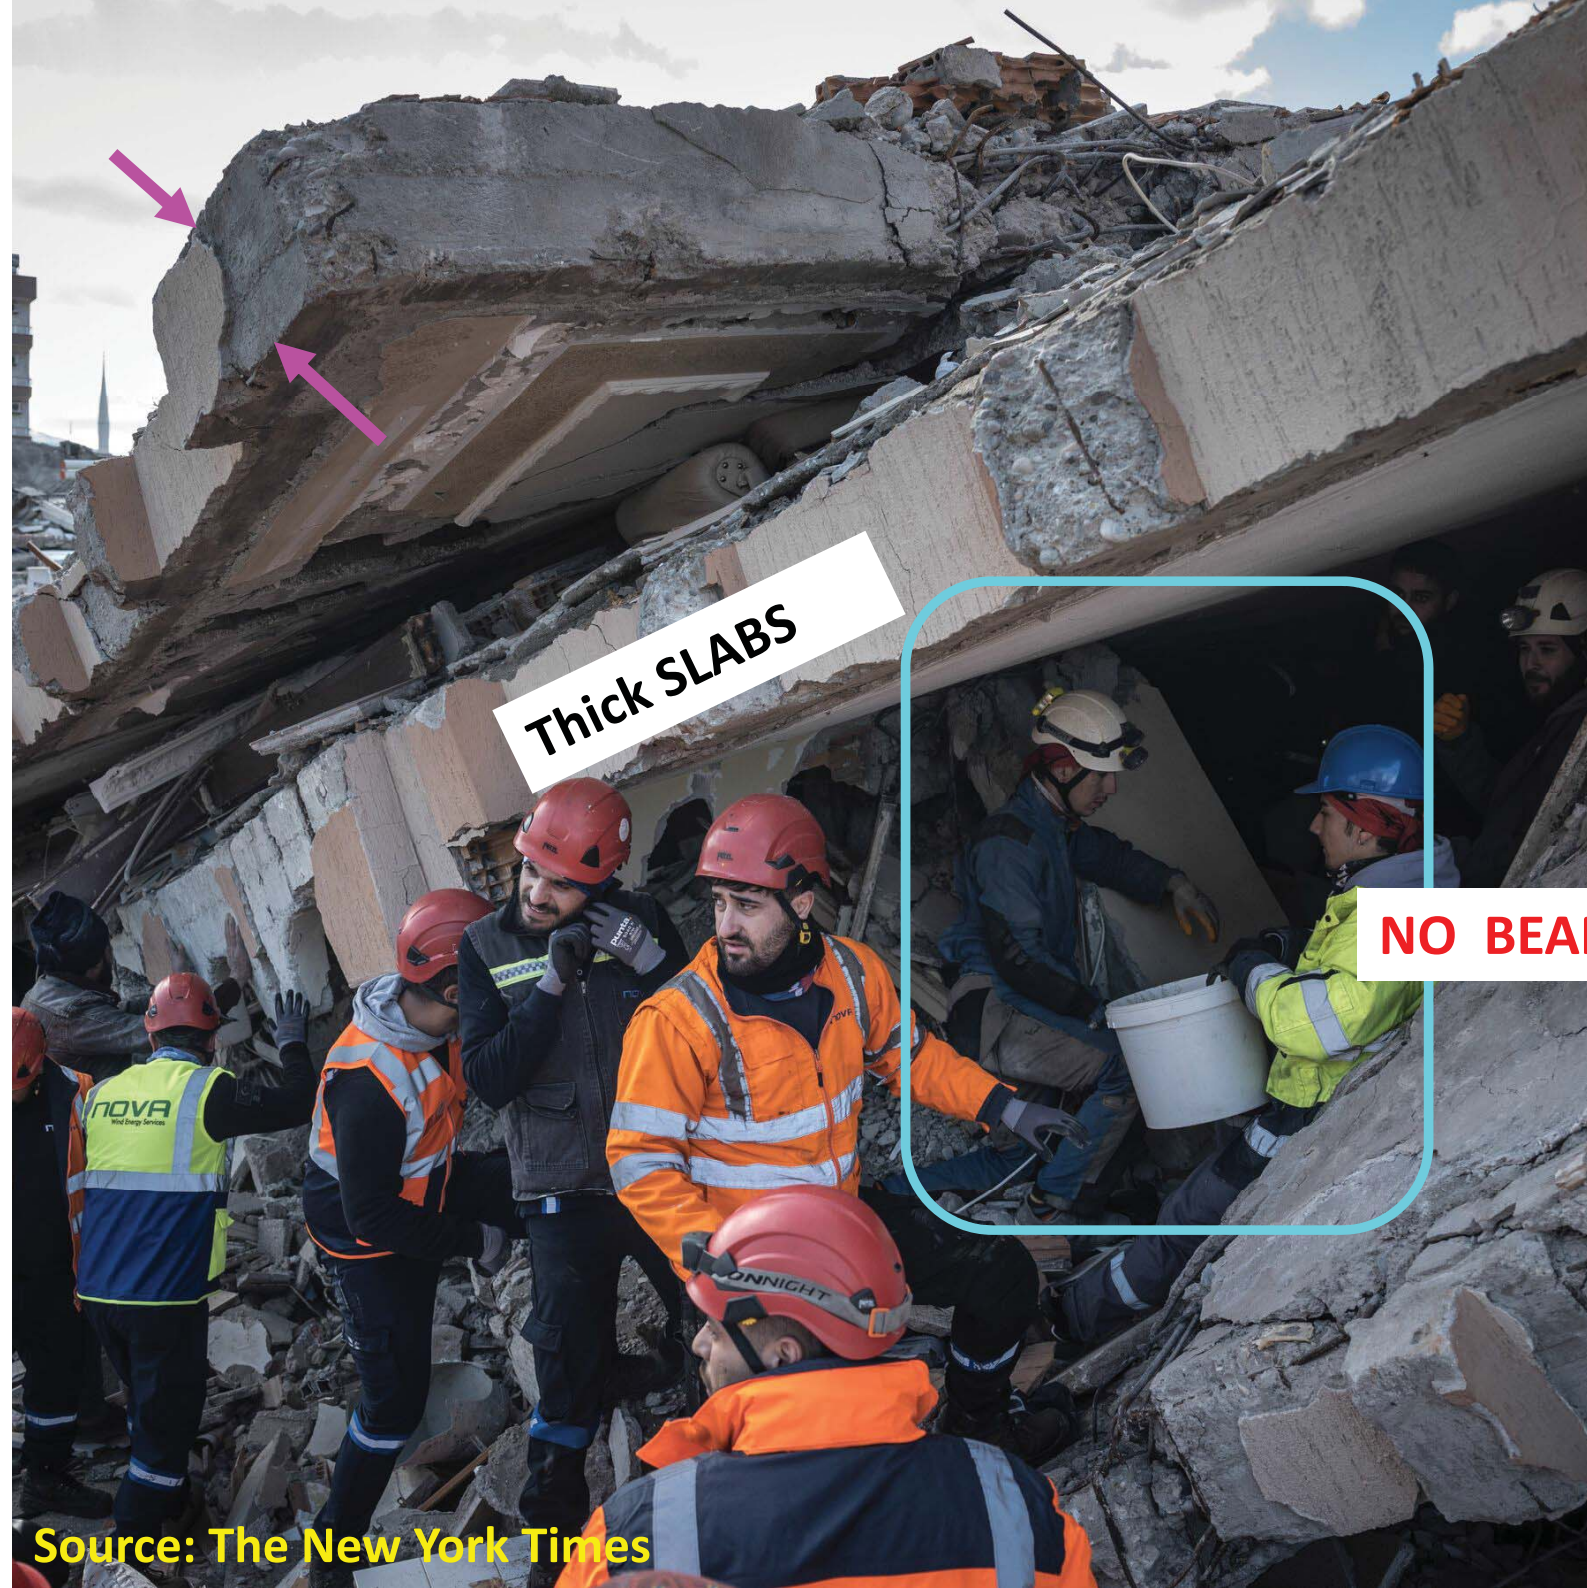
Thick SLABS

NO BEAMS, POOR JOINTS !

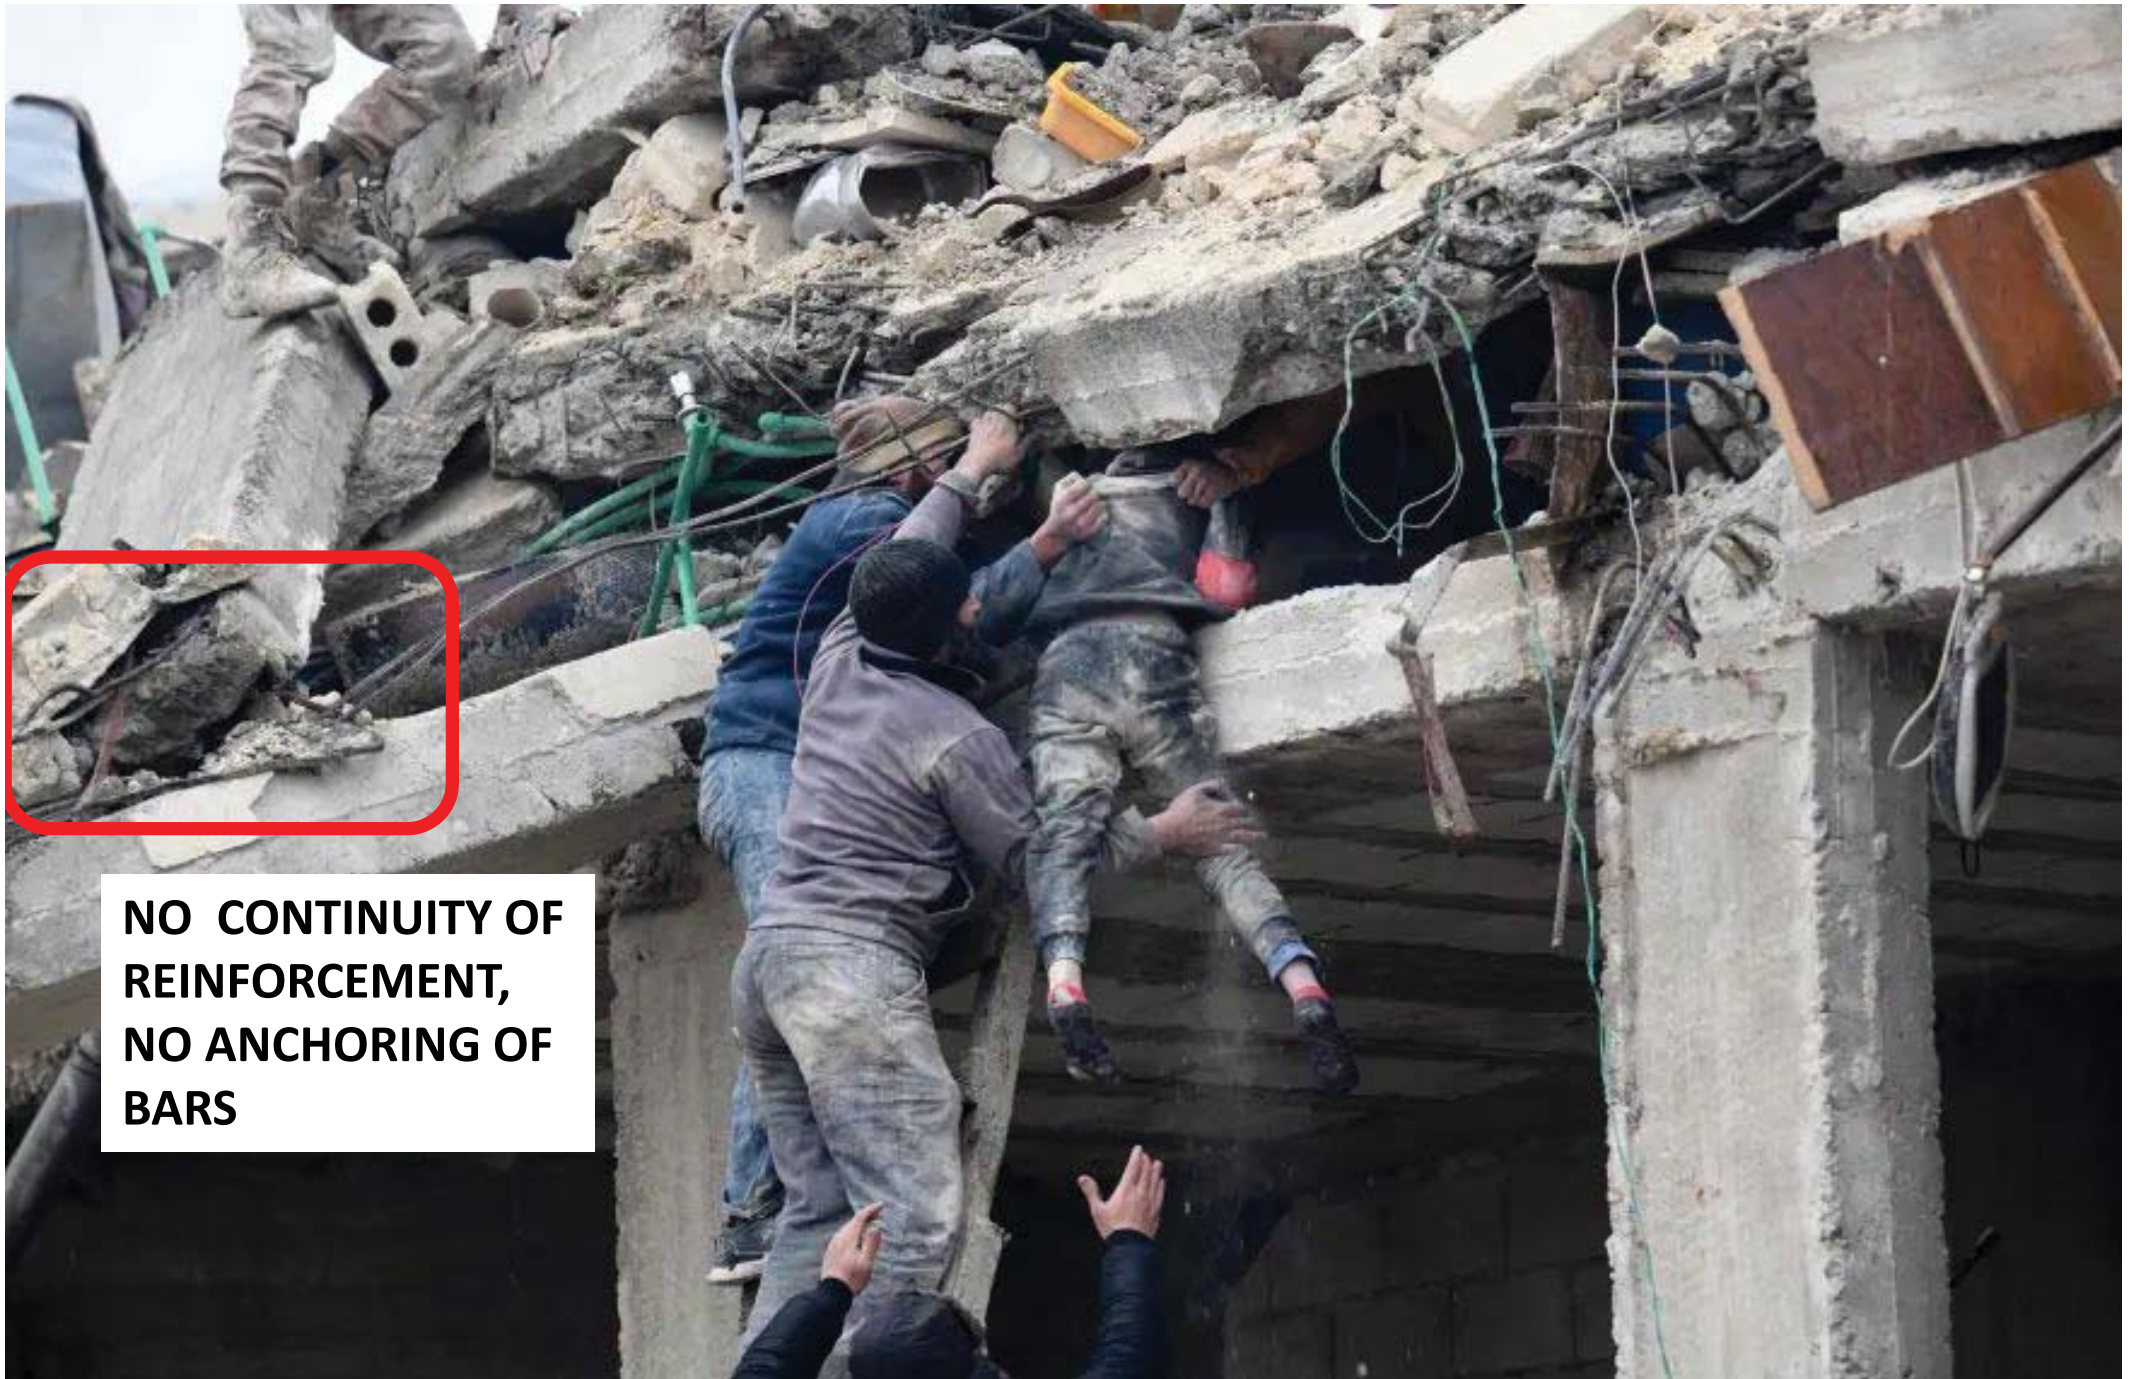
**NO CONTINUITY OF  
REINFORCEMENT,  
NO ANCHORING OF  
BARS**

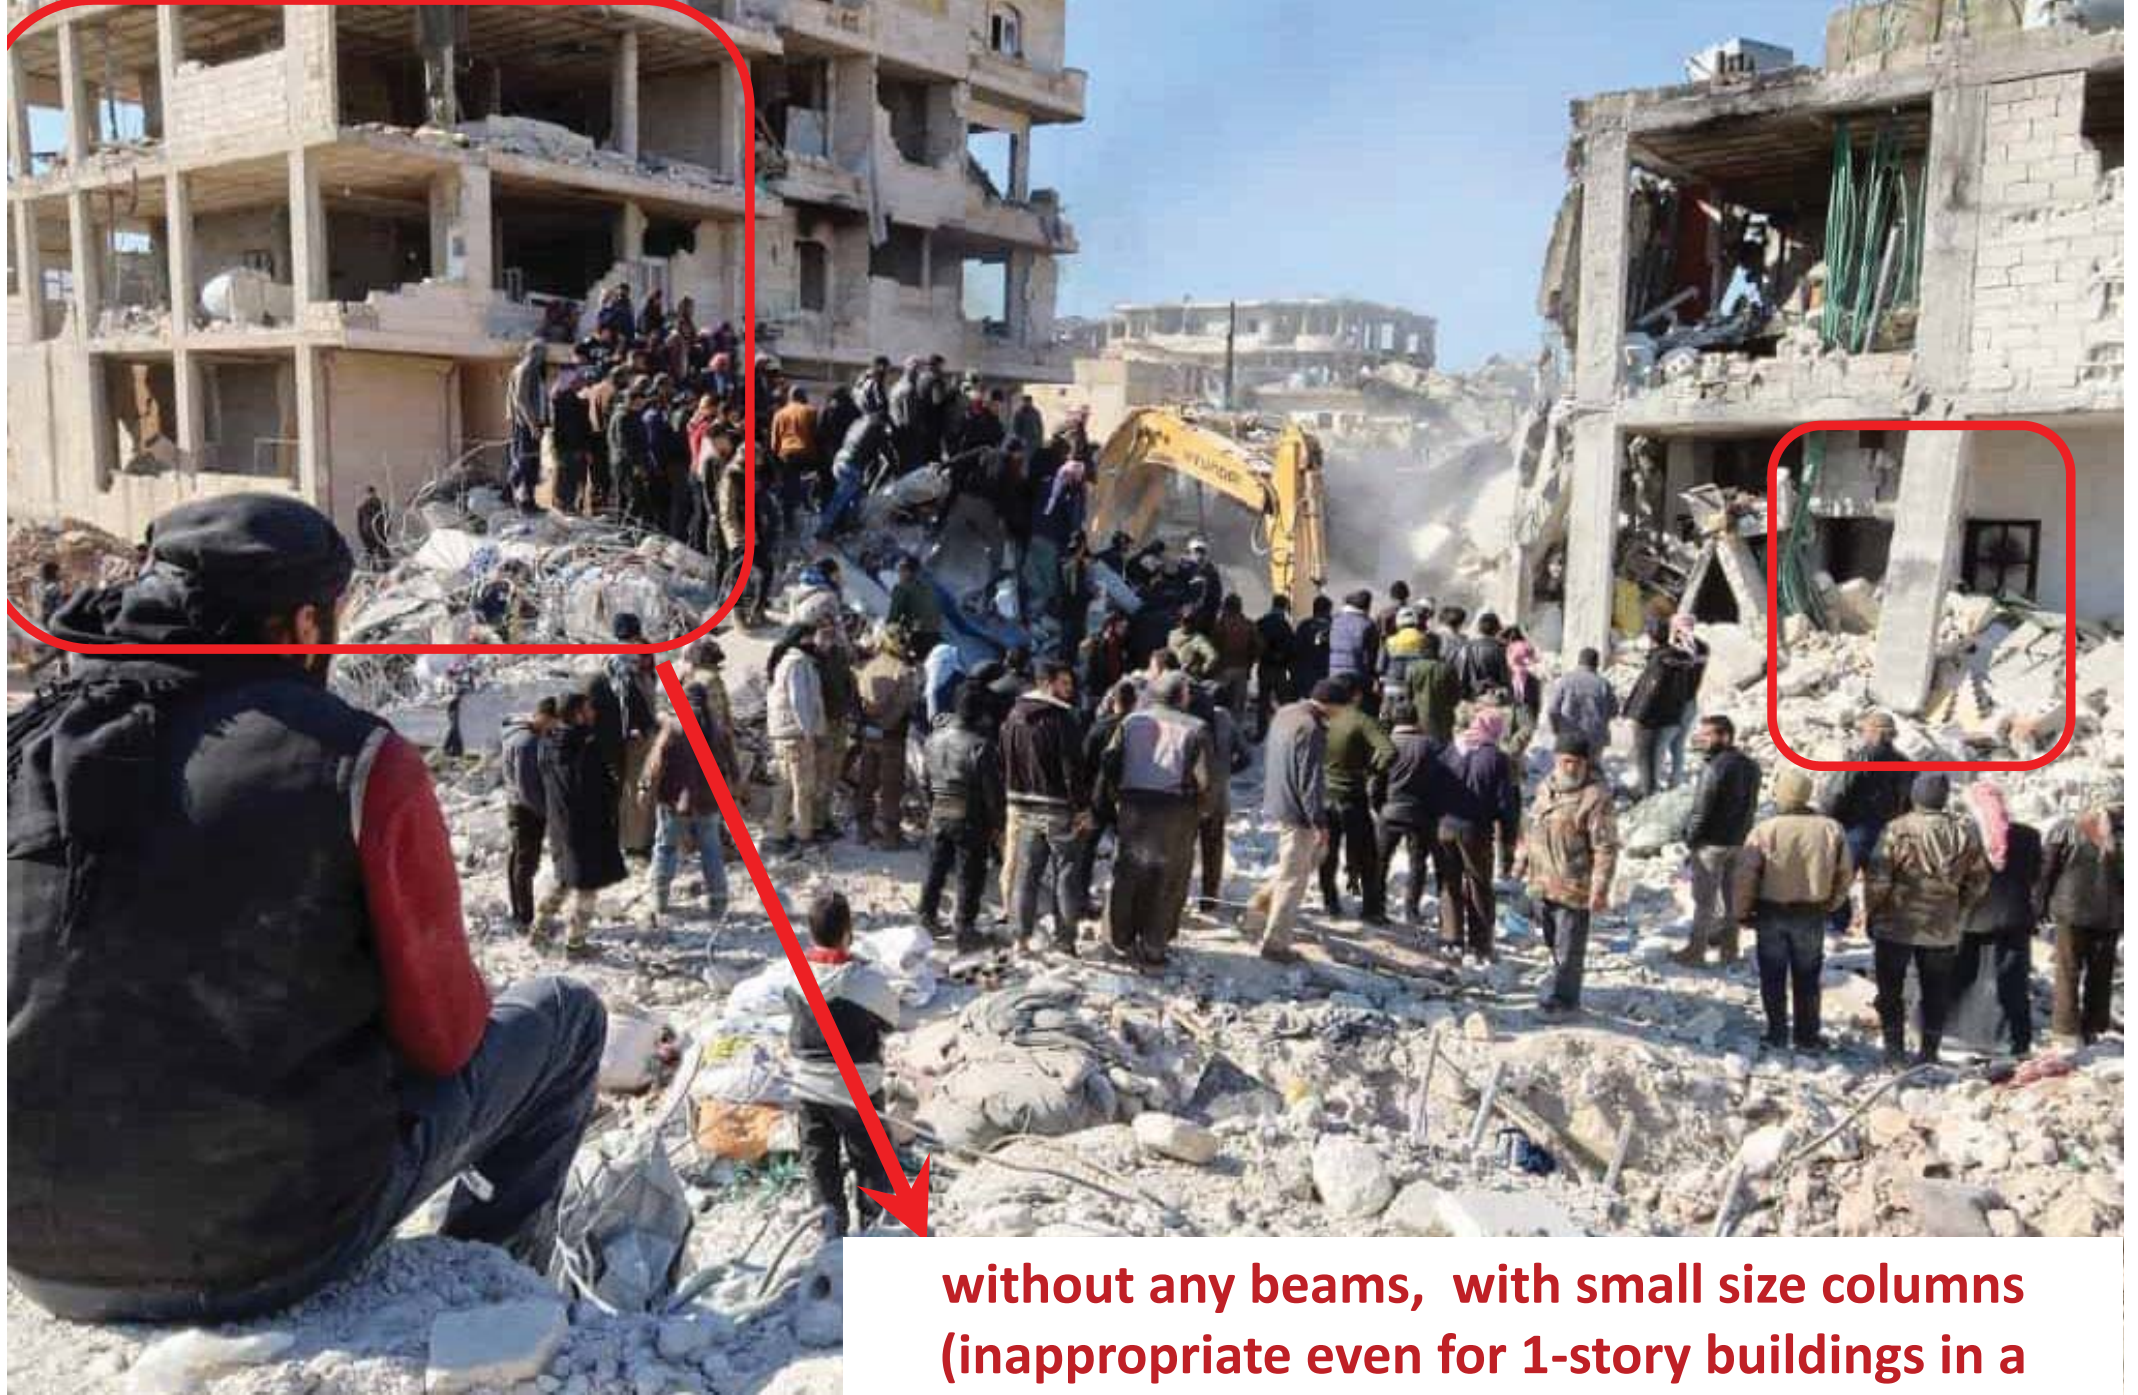
**without any beams, with small size columns (inappropriate even for 1-story buildings in a region of moderate seismicity). It is a miracle that it did not fully collapsed.**

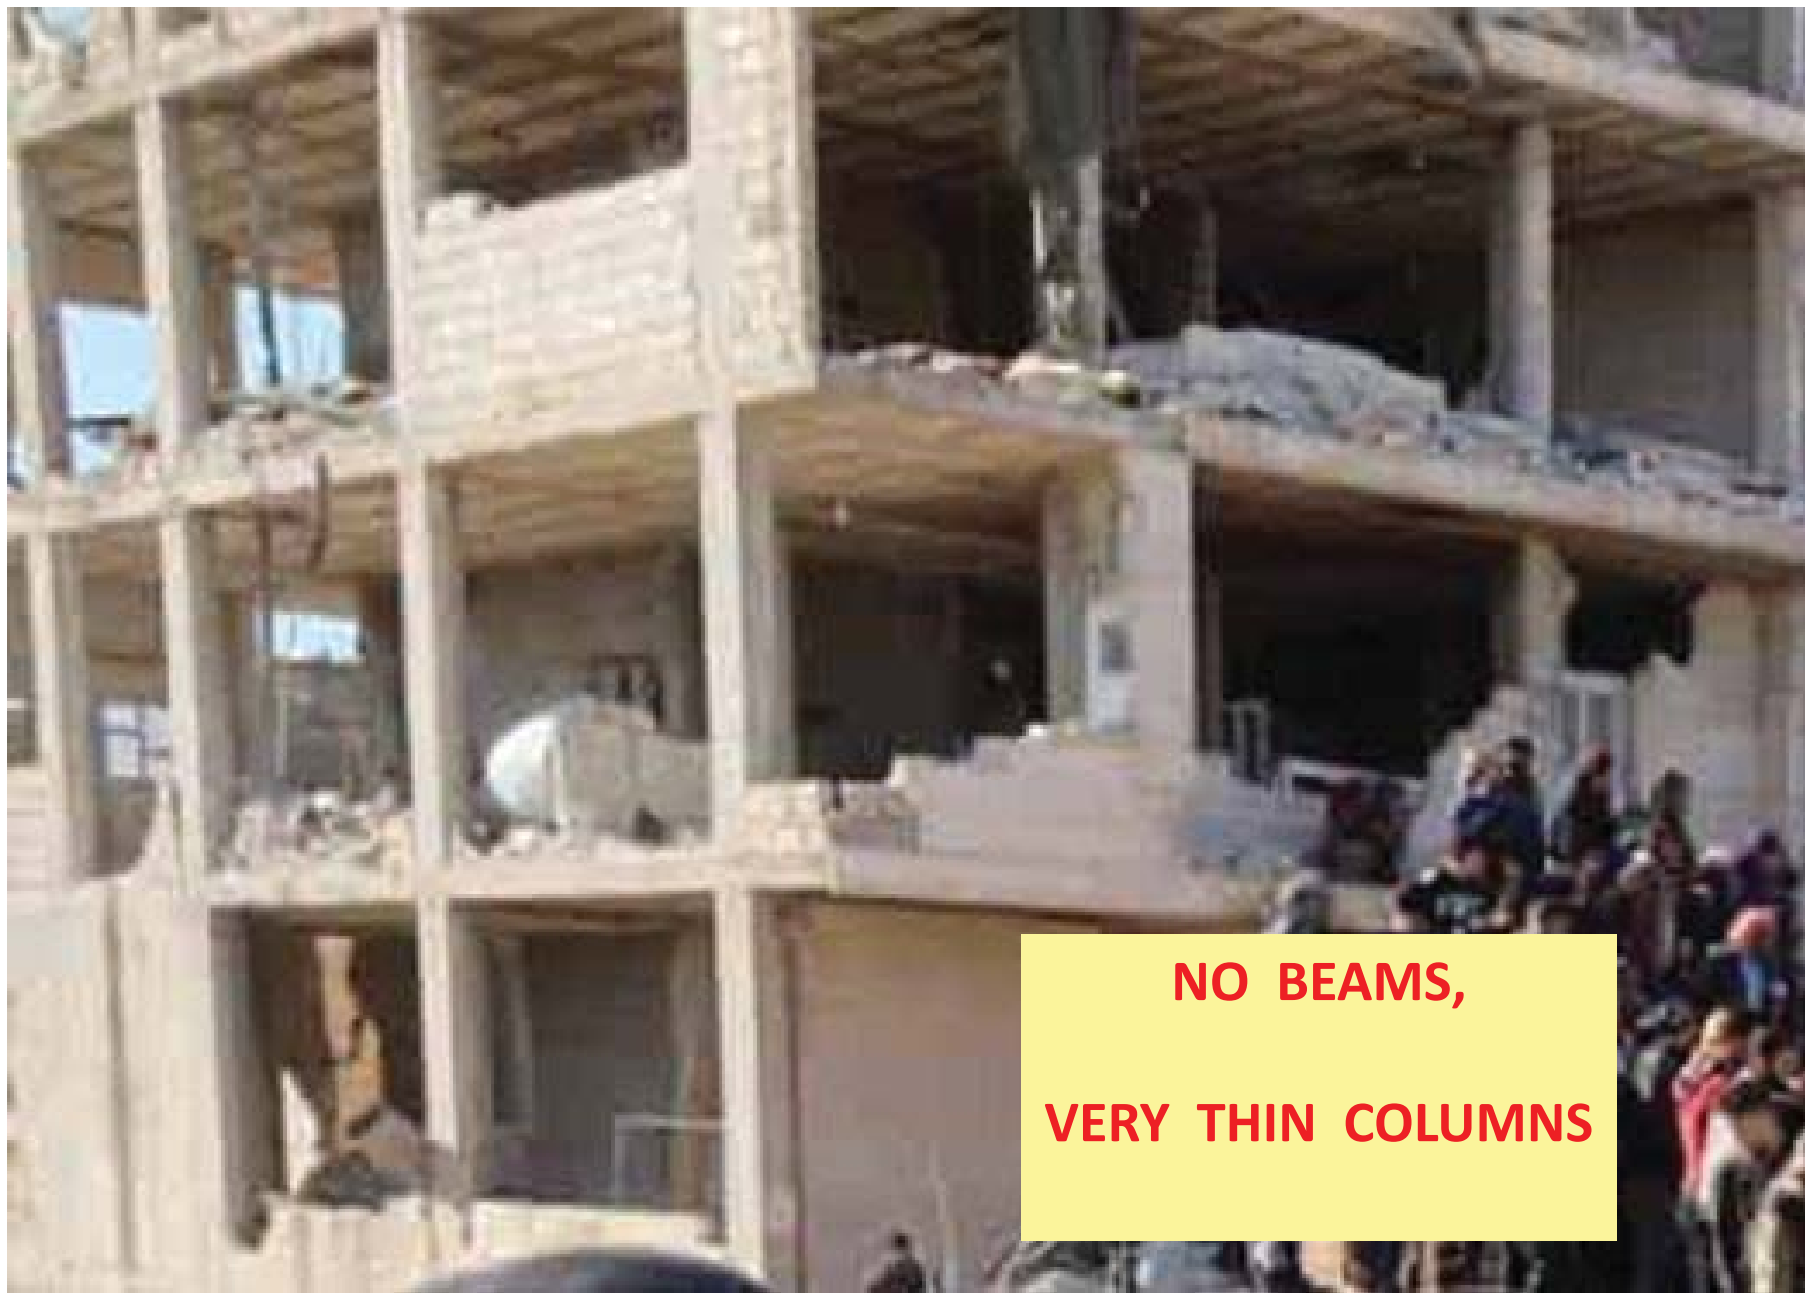
**NO BEAMS,  
VERY THIN COLUMNS**

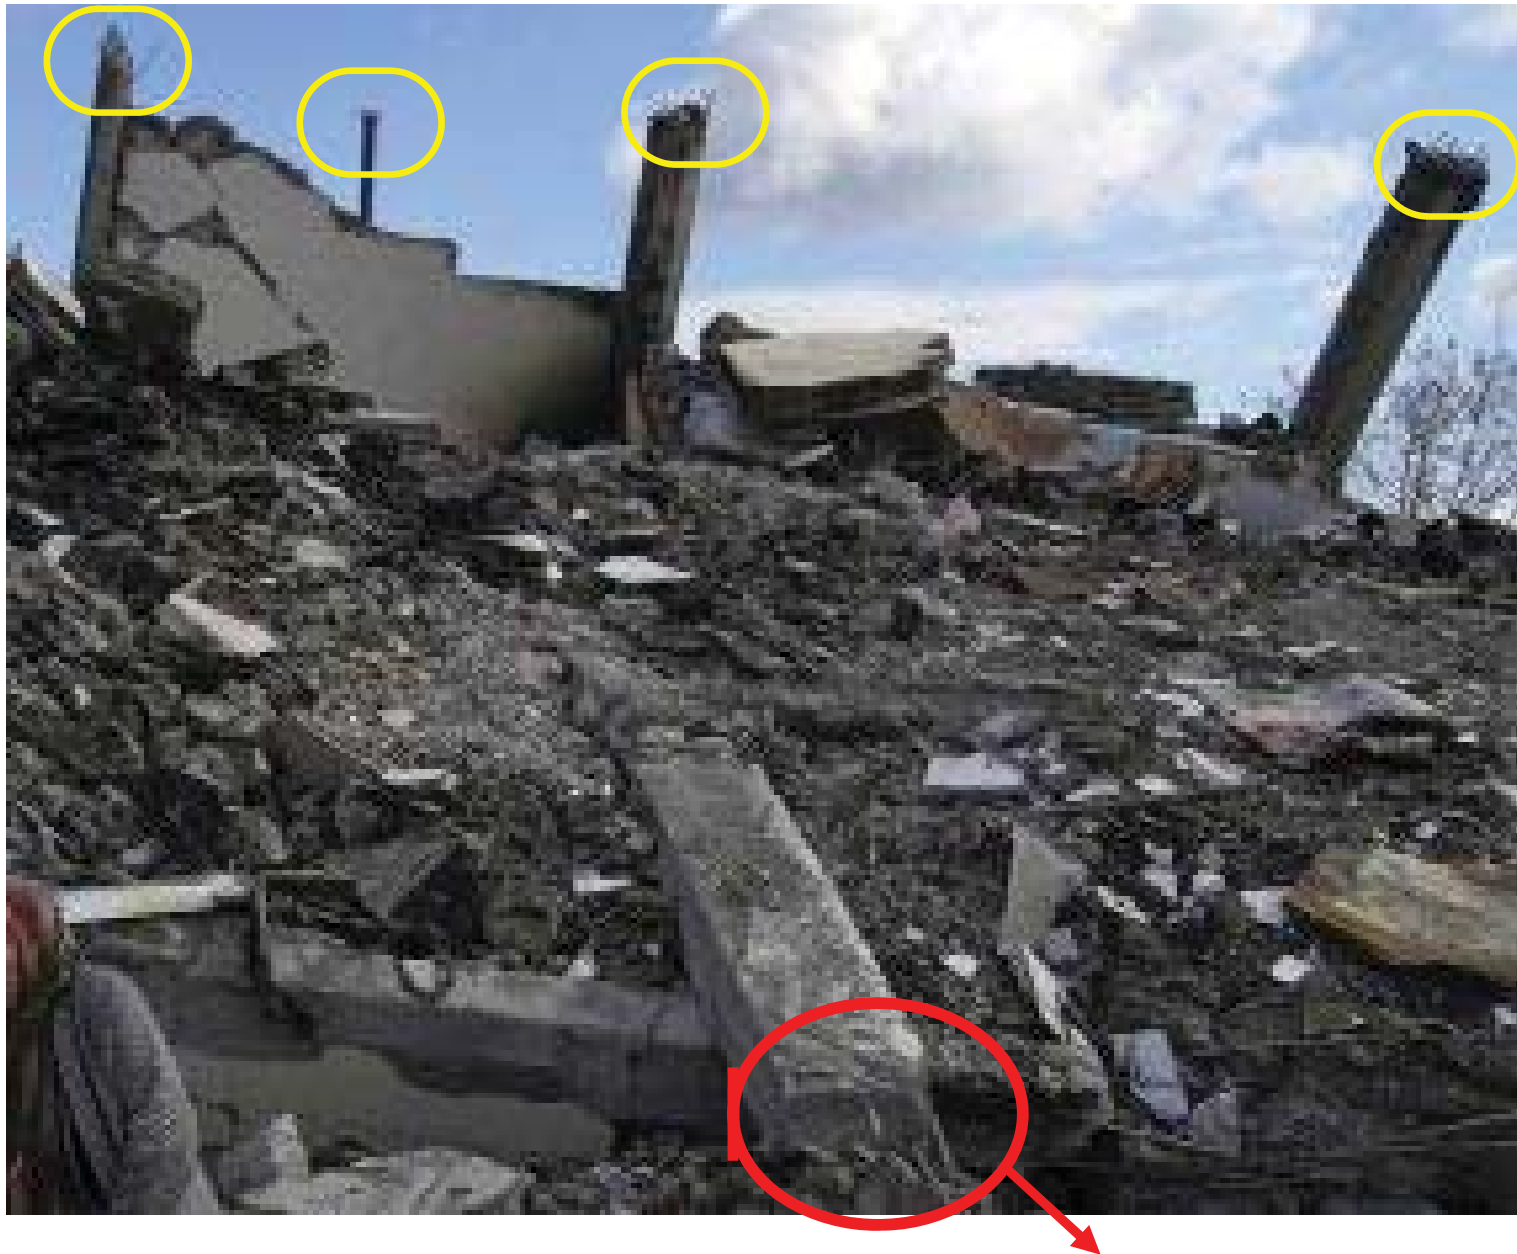
**VERY FEW REBARS OF VERY SMALL DIAMETER**

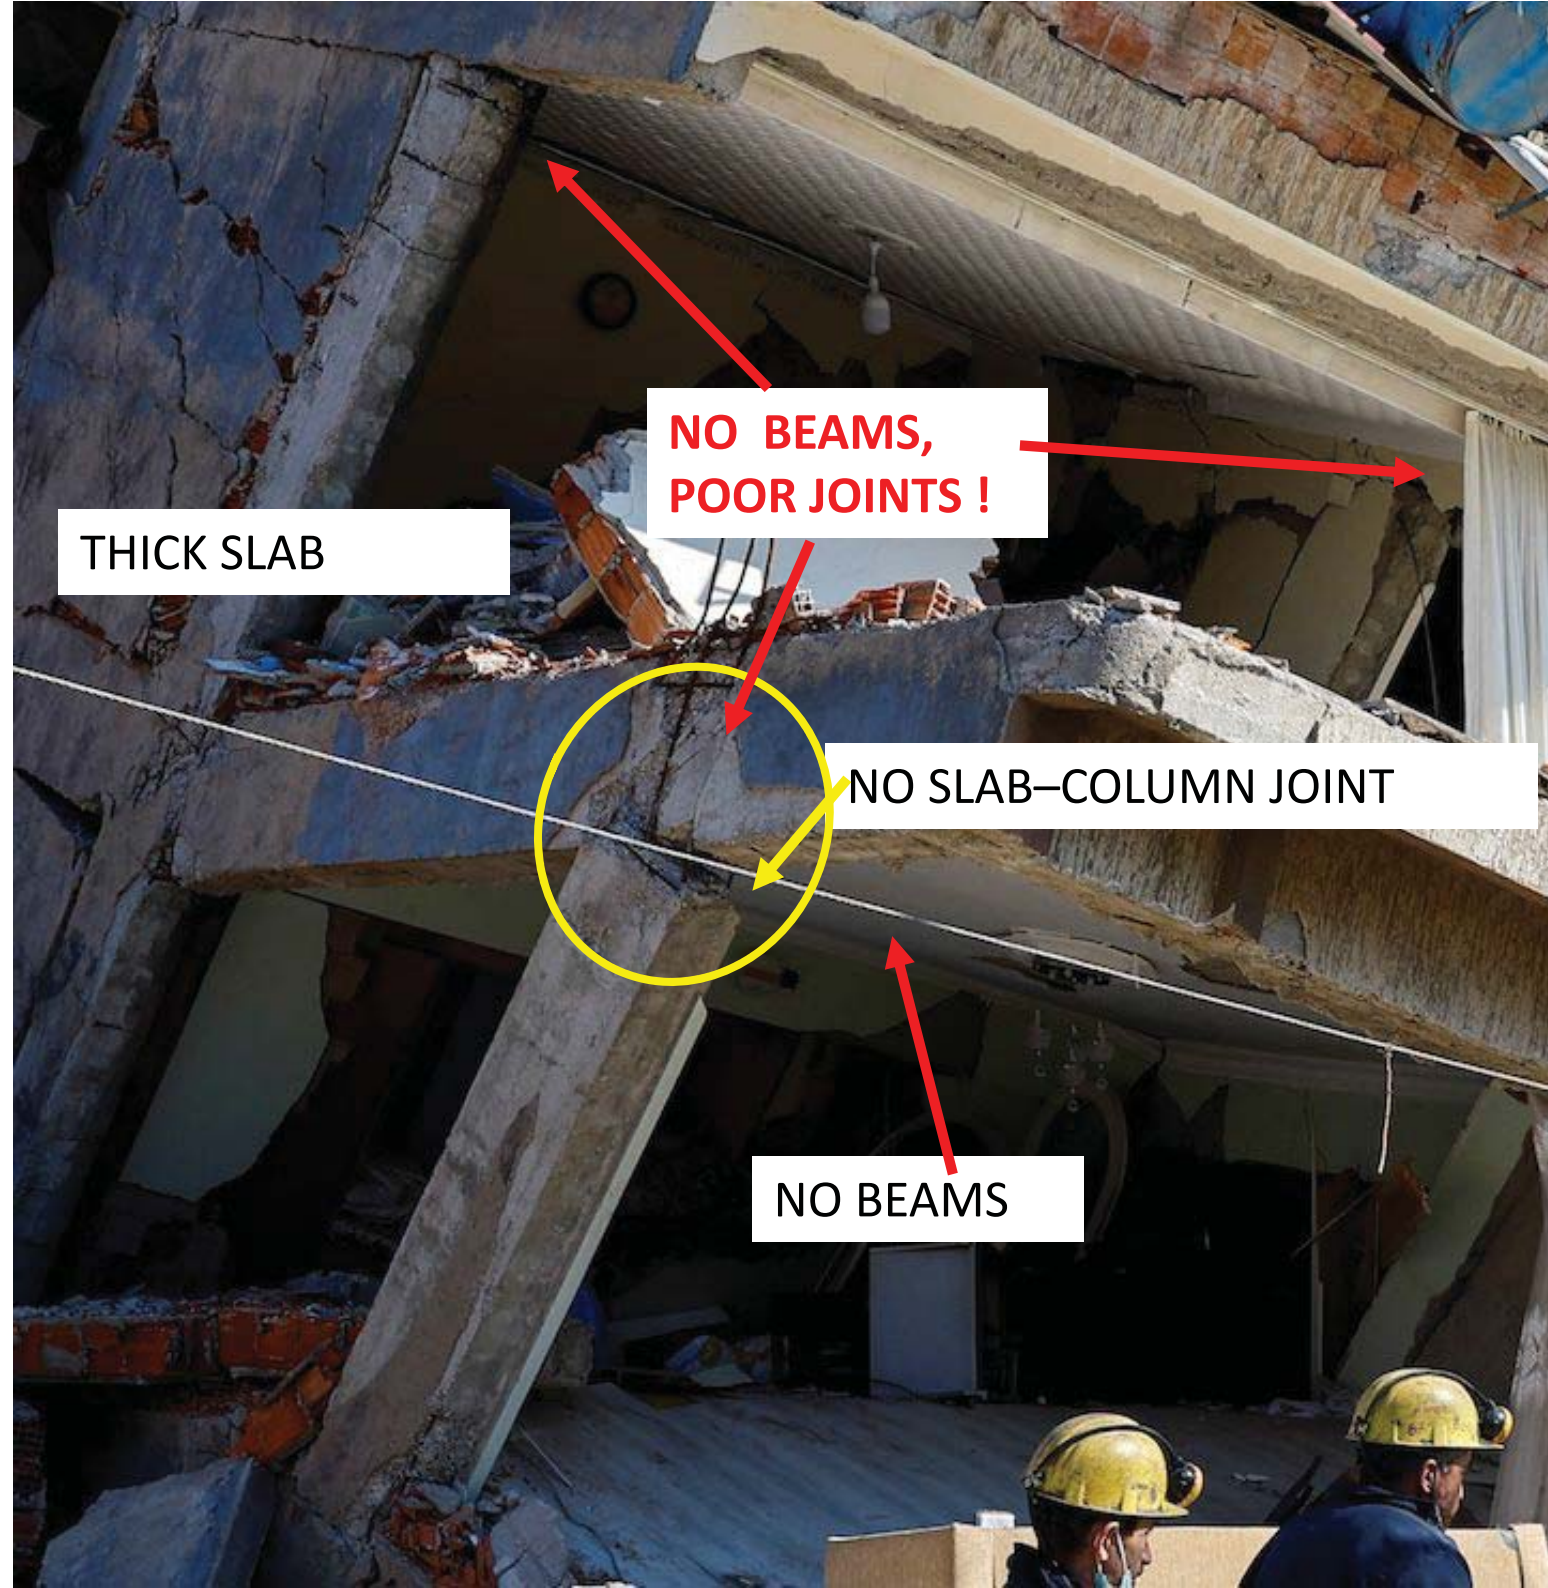
NO BEAMS,  
POOR JOINTS !

THICK SLAB

NO SLAB-COLUMN JOINT

NO BEAMS

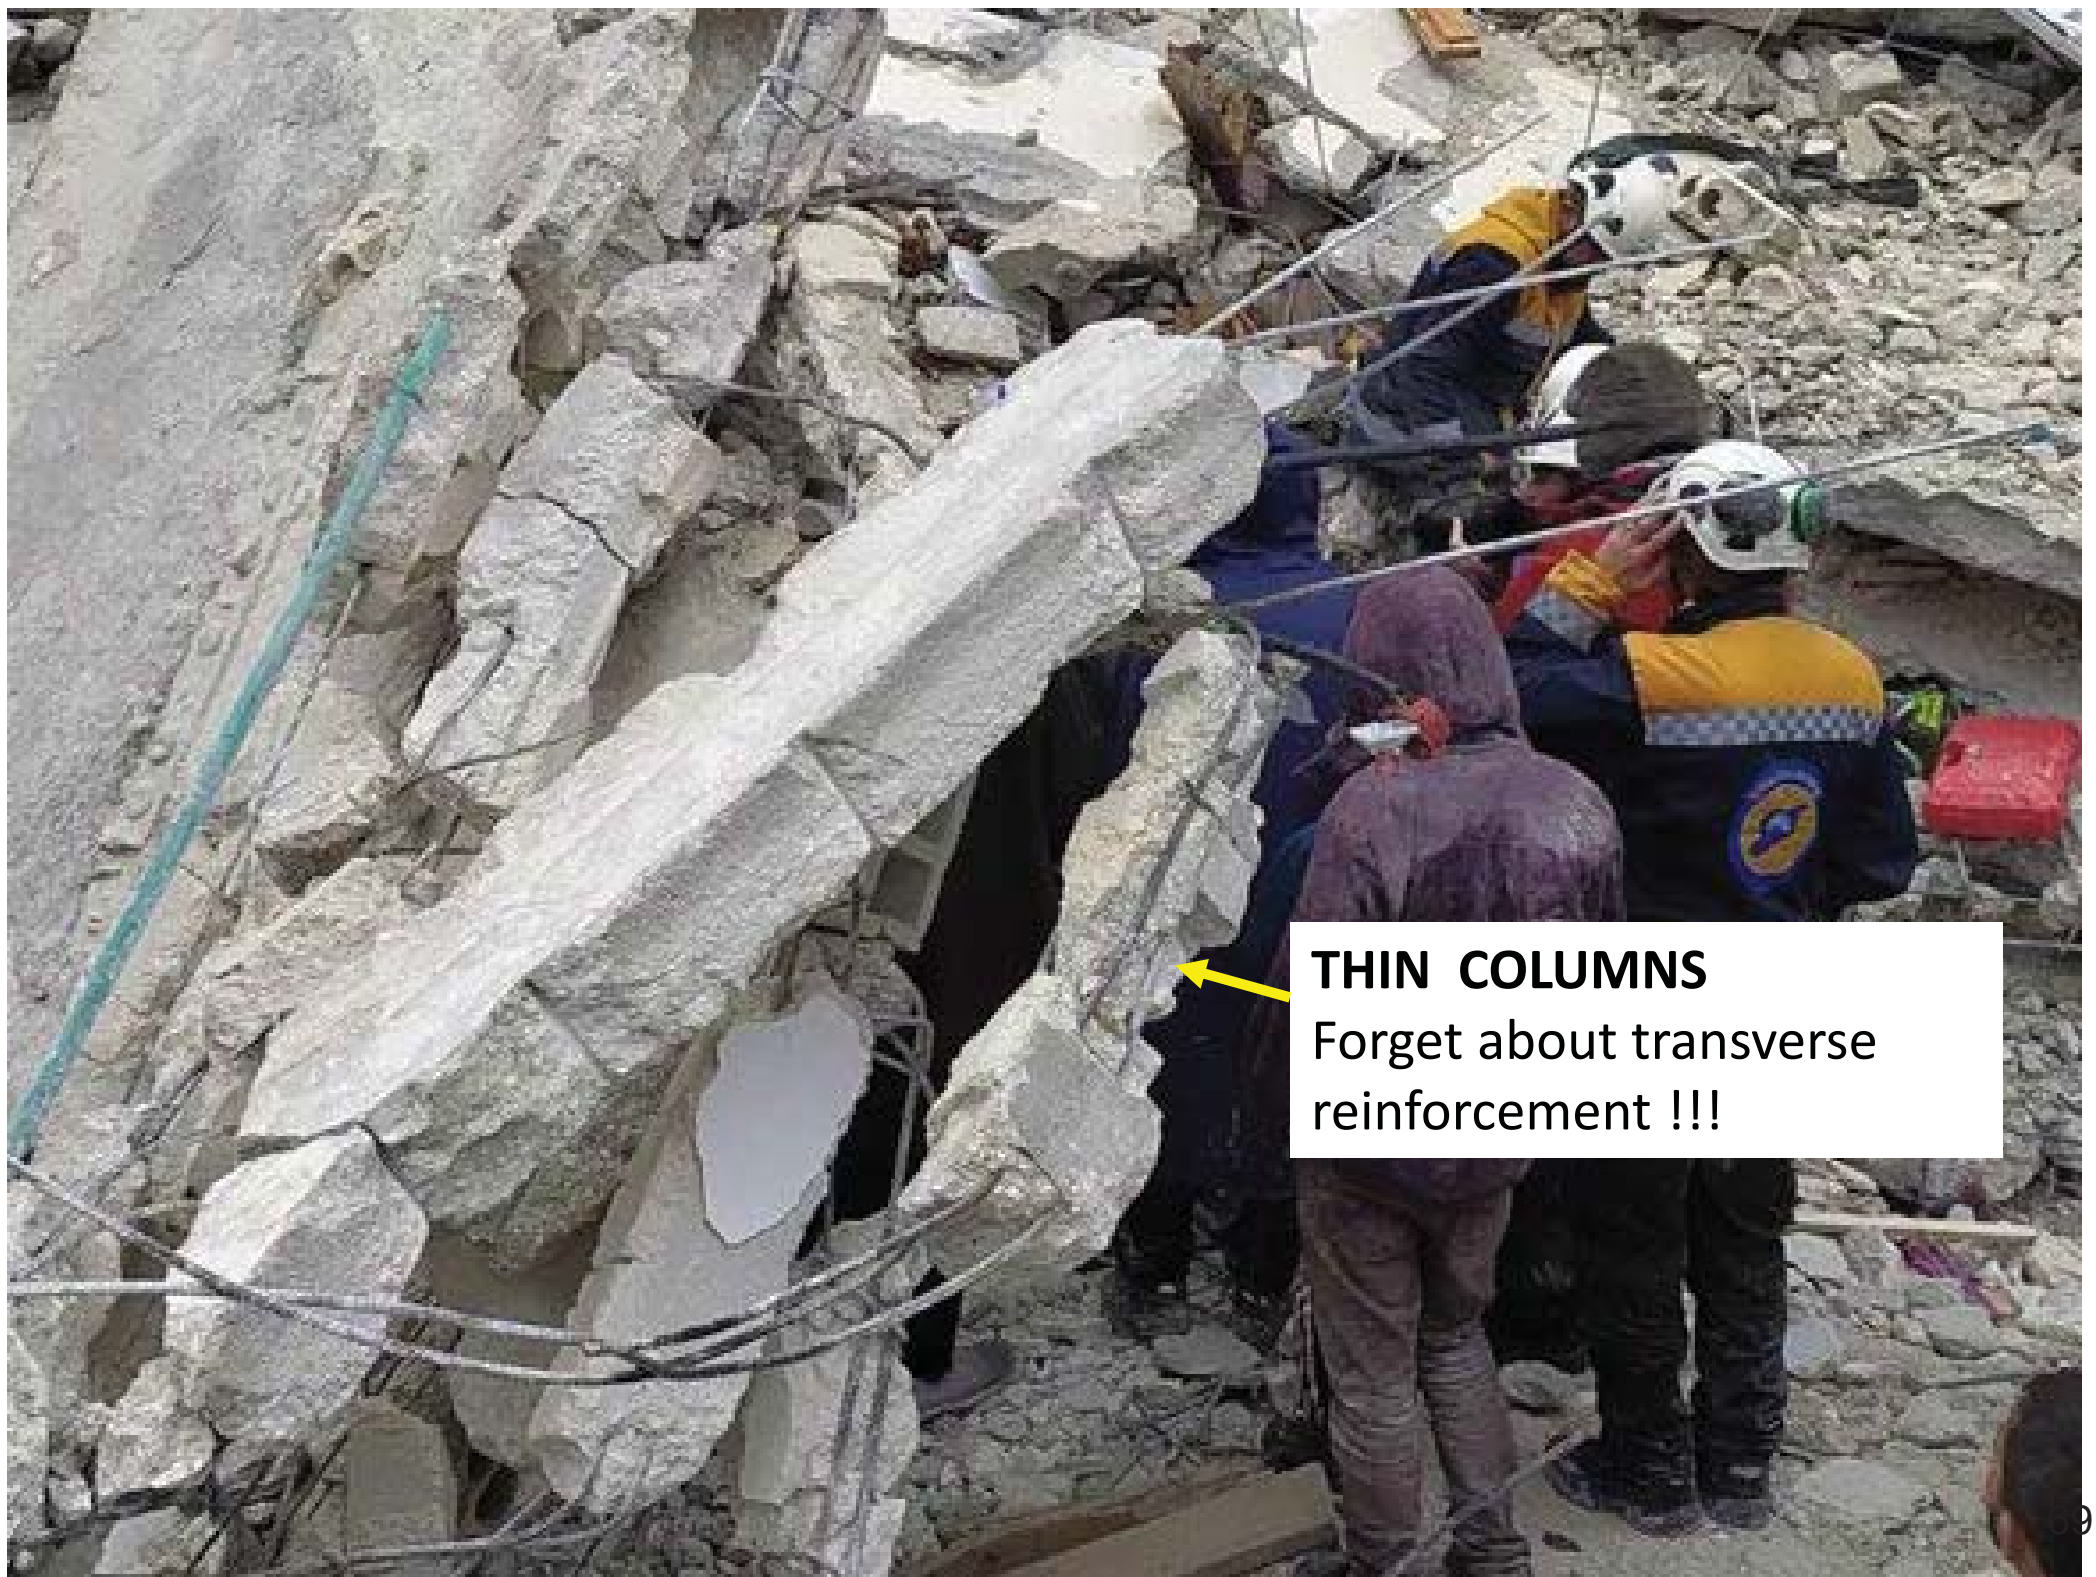
## THIN COLUMNS

Forget about transverse reinforcement !!!
