# Some critical reasons for the collapse of a huge number of buildings

## PART C

### **Recorded Accelerograms and their Response Spectra**

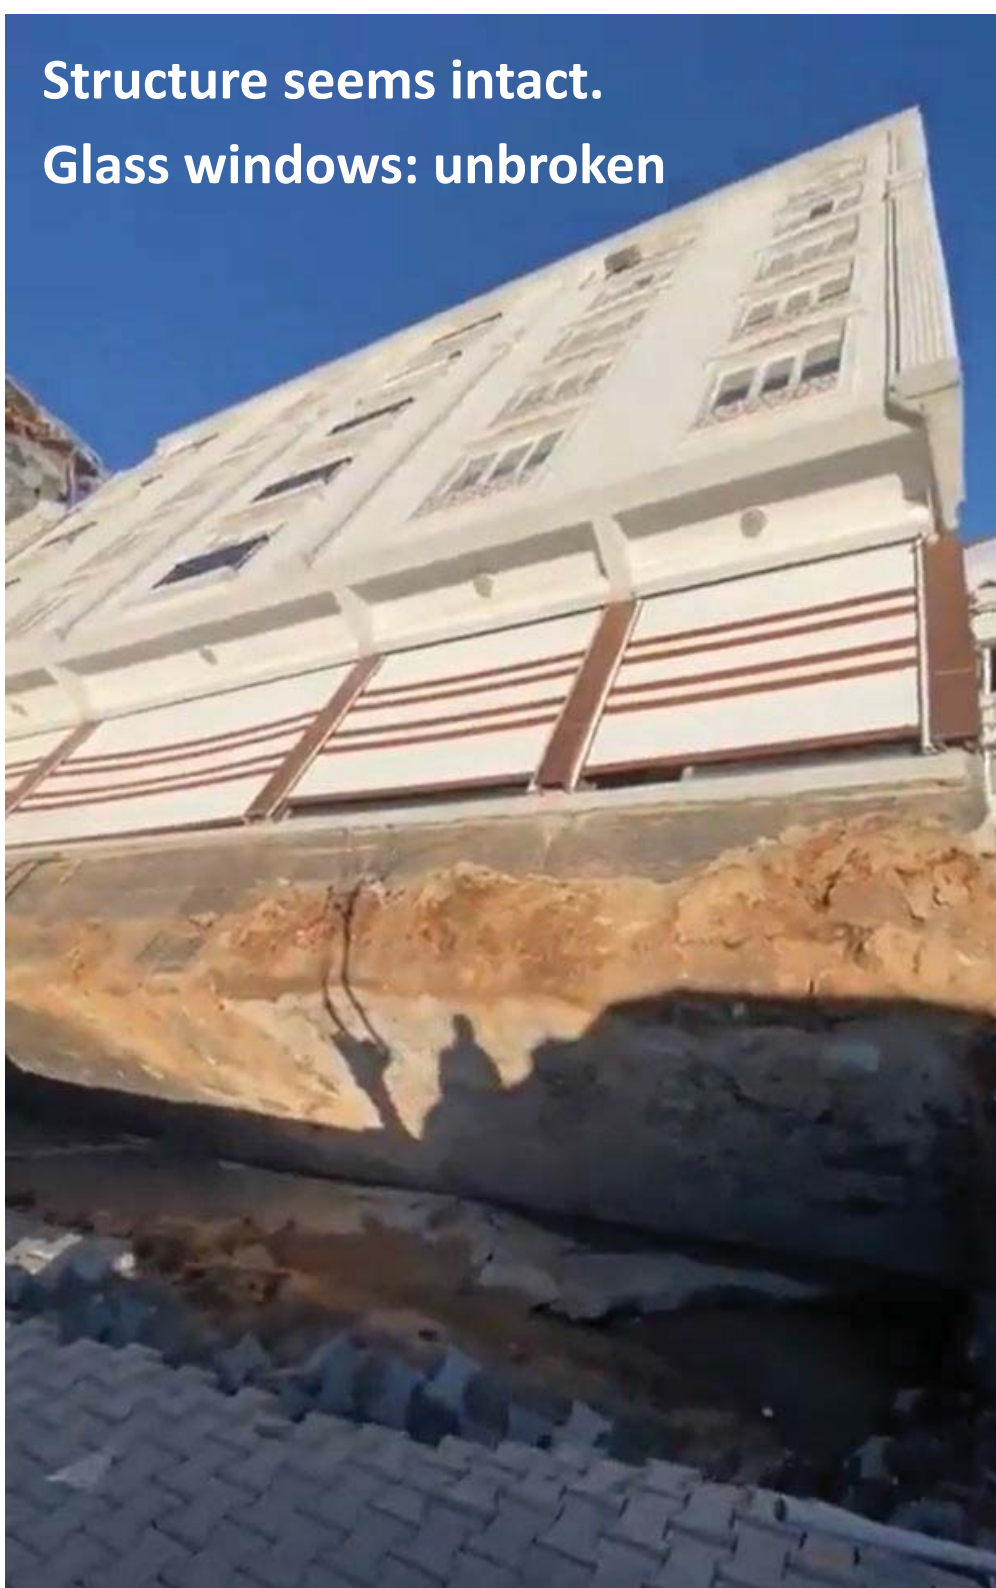
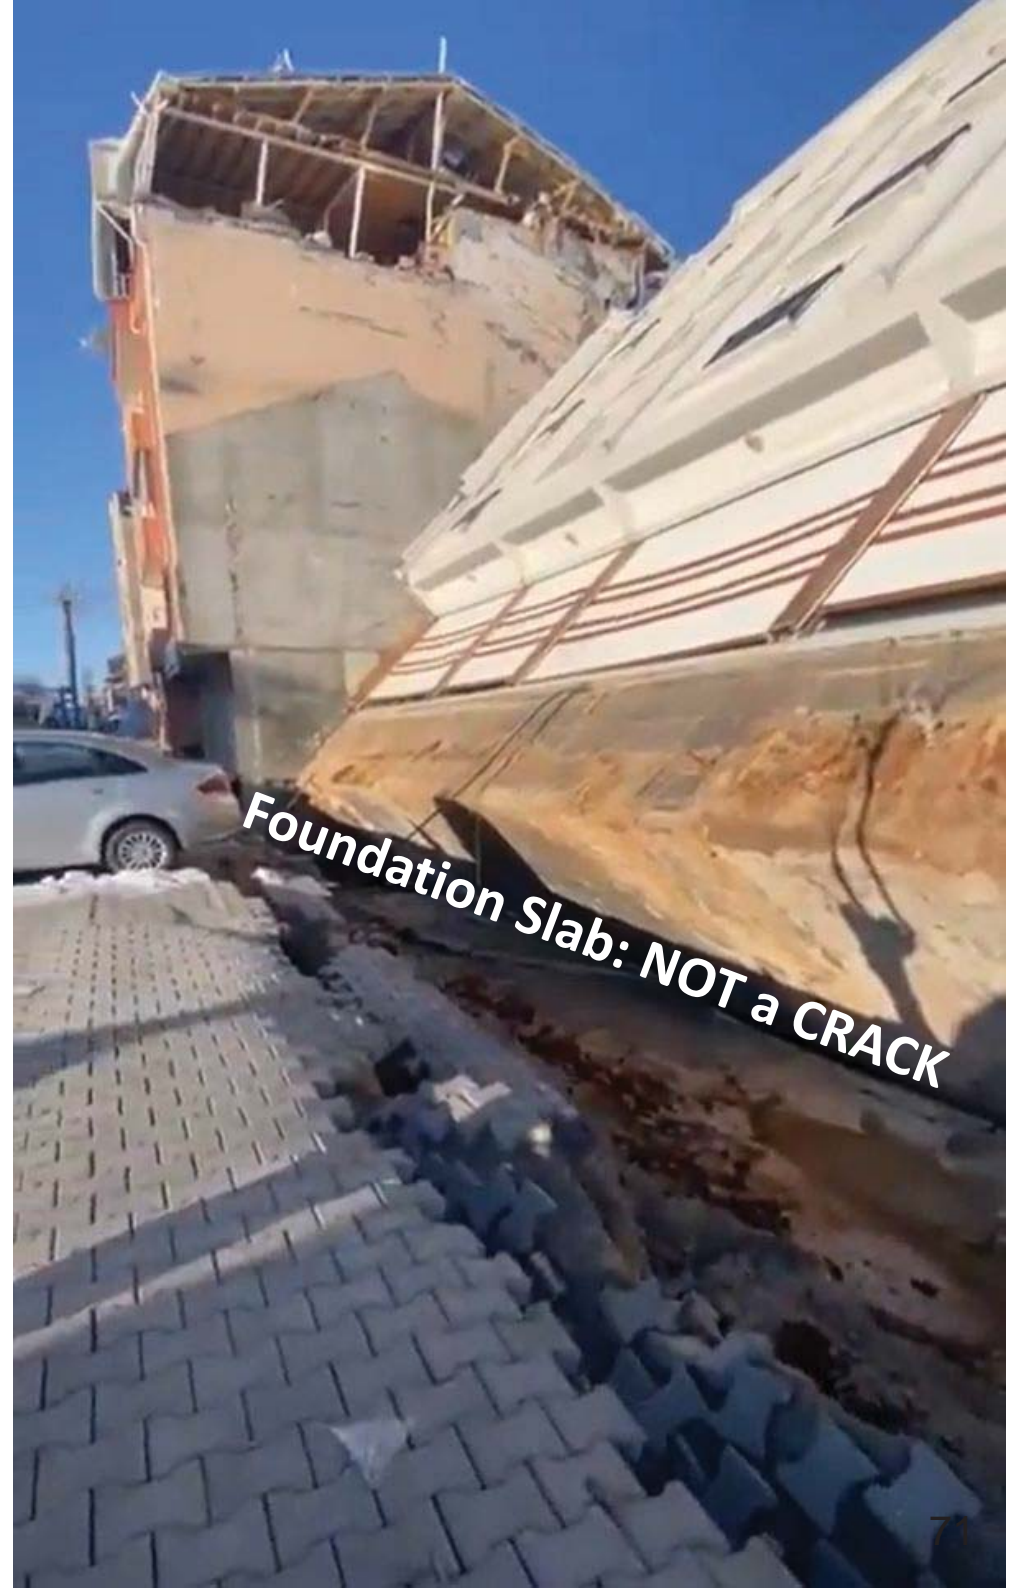
**Overturning of a building apparently due to bearing-capacity failure on soft soil (perhaps with a high water table) under strong seismic moment. No evident damage in the structure. The glass windows remain unscathed ! Similarly intact appears to be the foundation slab.**

Structure seems intact.  
Glass windows: unbroken

Foundation Slab: NOT a CRACK
